## Port State Control Issues – Australian Maritime Safety Authority

*The following concerns were provided by the Australian Maritime Safety Authority. They have been extracted from a series of separate emails in the period December 2016 to February 2017. Discussion with AMSA's Principal Marine Surveyor indicate their strong hope that the scope of "S Mode" will be sufficient for ship's staff to more easily and effectively manage ENC subscriptions, permits and ENC update status, and to be able to demonstrate this to Port State Control inspectors.*

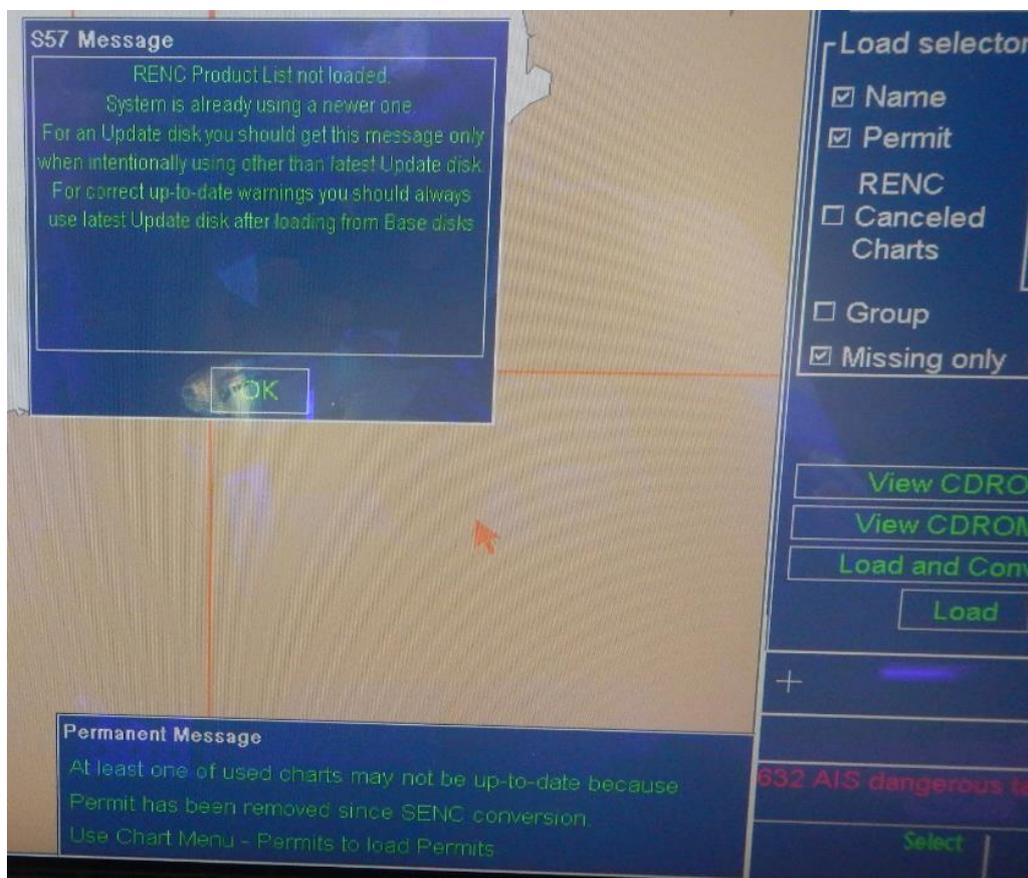
As per previous emails we have found that if the ECDIS ENC Base Discs (usually updated monthly) are not loaded then the following ENC updates (usually weekly by email) will not be accepted by the ECDIS. This will also happen when a ship changes operators and the new operators obtain their ENC permit from another provider. I have even seen this when the new company uses the same provider and are issued a new permit. It seems many deck officers are not aware of this and do not realise the ENCs are not updated.

Last week we inspected a ship that had been laid up by the owners for 9 months due to lack of a charter. We found that several of the ENCs for the intended voyage were not updated. The ship had been laid up cold (that is without crew) so the ECDIS ENCs was not updated during those 9 months. The ENCs were updated when the ship was brought back into service, however because the ENCs were not updated in the previous 9 months the updates were not accepted by the ECDIS. To cut a long story short, the ENC could only be updated after all the updates for the missing 9 months were loaded with the assistance from the ENC provider. It took several hours to download the updates and would have cost a small fortune in data.

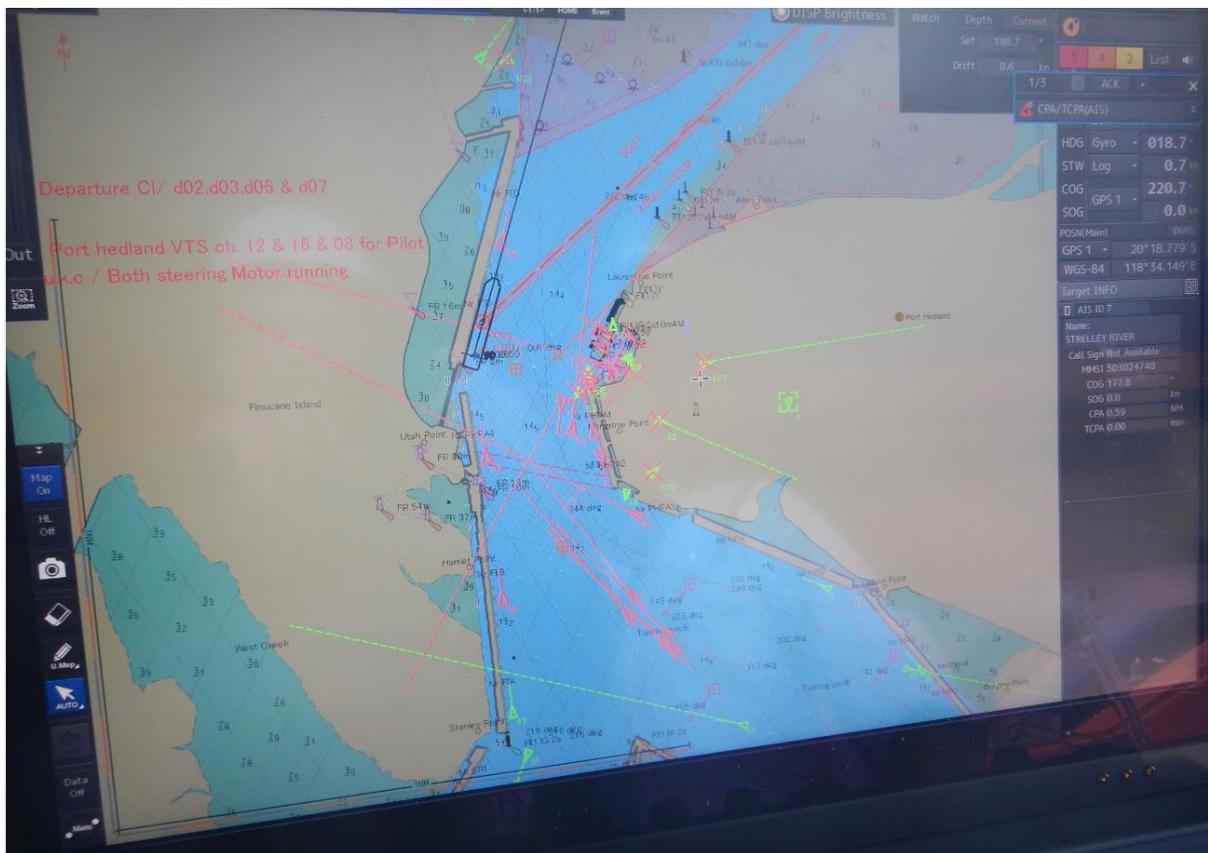
See below ECDIS screen with the AIS ship targets displayed over land. I have not seen this before, has anyone else seen this or something similar? In this case when the No1 ECDIS was zoomed in or out some of the AIS targets persisted in the same position on the ECDIS screen however the same thing did not happen on No2 ECDIS. When I asked the attending deck officers what the targets were over the land they told me that those targets were planes or helicopters. After I pointed out that those were ship targets and persisted in the same position on the screen when the scale was changed, the deck officers admitted they had observed the AIS error several times on that ECDIS but not on the other ECDIS. The ship was her maiden voyage and a company superintendent had been on board since before the ship left the shipyard. He was present on the bridge when I inspected the ECDIS and discovered the problem. He told me that he had not been informed there was an issue with the ECDIS AIS interface and naturally he became annoyed with the deck officer and master. I did not issue a deficiency as the superintendent said he would submit a warranty claim and contact the manufacturers for advice. A note was put on the No1 ECDIS alerting about the AIS targets. By the way the one target that is acquired, the Strelley River, is actually on land, it is under repair in the workshop.

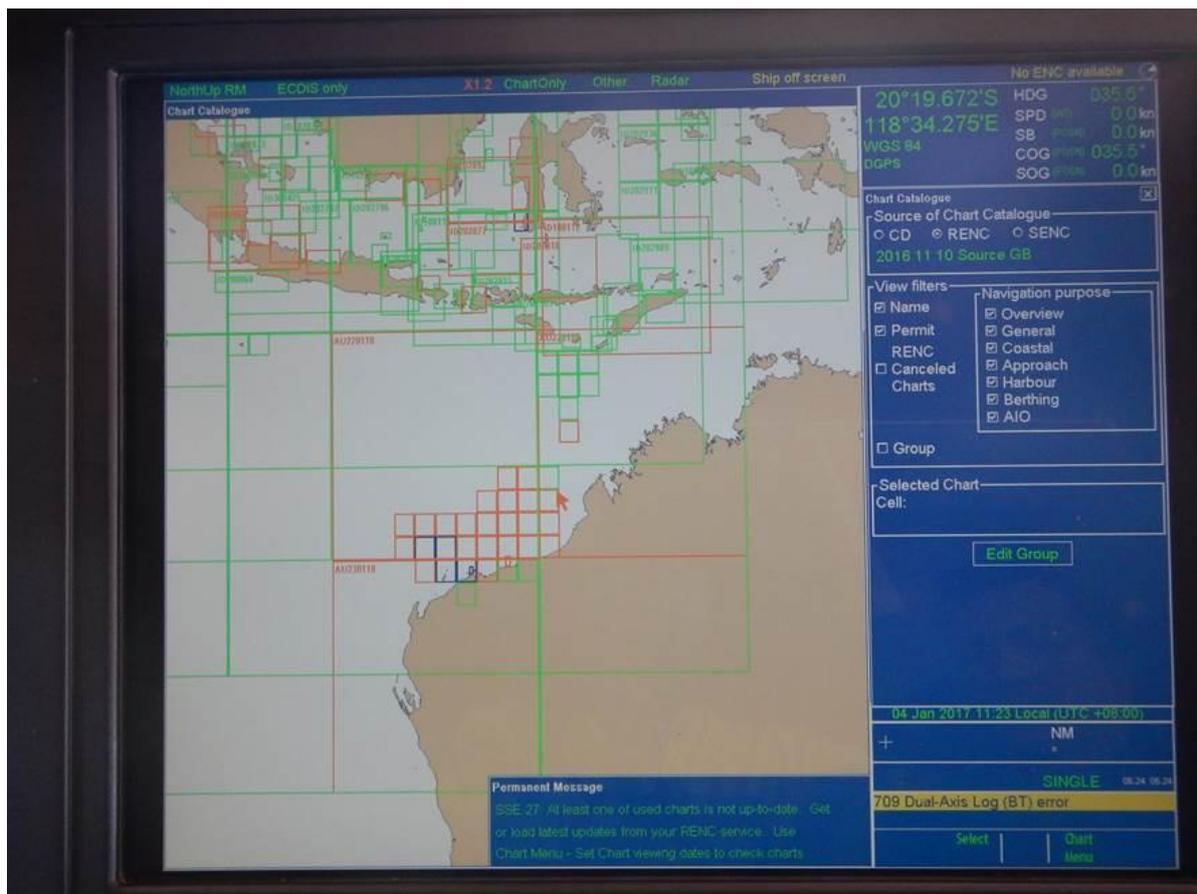
When the ship was inspected 4<sup>th</sup> Jan 2017 the ECDIS ENC's had not been updated since week 45 of 2016. See the photo below showing the ENC; the red ENC cells are not corrected up to date (colour appears orange on photo). The master said that the ENC are updated with CD's delivered to the ship rather than by email download. He said that he was unable to update the ENC by email download because he had not received the CD with the ENC base update. The premise being that any ENC updates, whether by CD or email download issued subsequent to the latest base update, cannot be loaded into the ECDIS. This is very similar to the issue I recently found on another ship where the ENC updates were not loading into the ECDIS because the newest CD catalogue had not been loaded into the ECDIS. The ship had changed the management company and RENC provider so the CD catalogue was not recognised by the new RENC updates. In that case the master and navigating officers were not aware that the ECDIS ENC were not updating. See attached email FYI.

There are several issues here, one is that the companies are saving the cost of data transfer by obtaining ENC updates by CD rather than email download even though the CD's make take several weeks to reach the ship and there is the possibility some will be lost in transit.

The other issues are that while the ENC are being updated by CD or email download as required some officers are not recognising when the updates are failing and are accepting that it is OK that the last ECDIS ENC updates were two months ago. If the ship had been using paper charts for navigation I am sure the master would have made more effort to obtain the latest chart corrections.

The ship was able to download the ENC base update from the SENC however this took several hours because of the data transfer speeds and was not completed until the early hours of the morning. Yan was very pleased to receive the phone call from the master at that time.

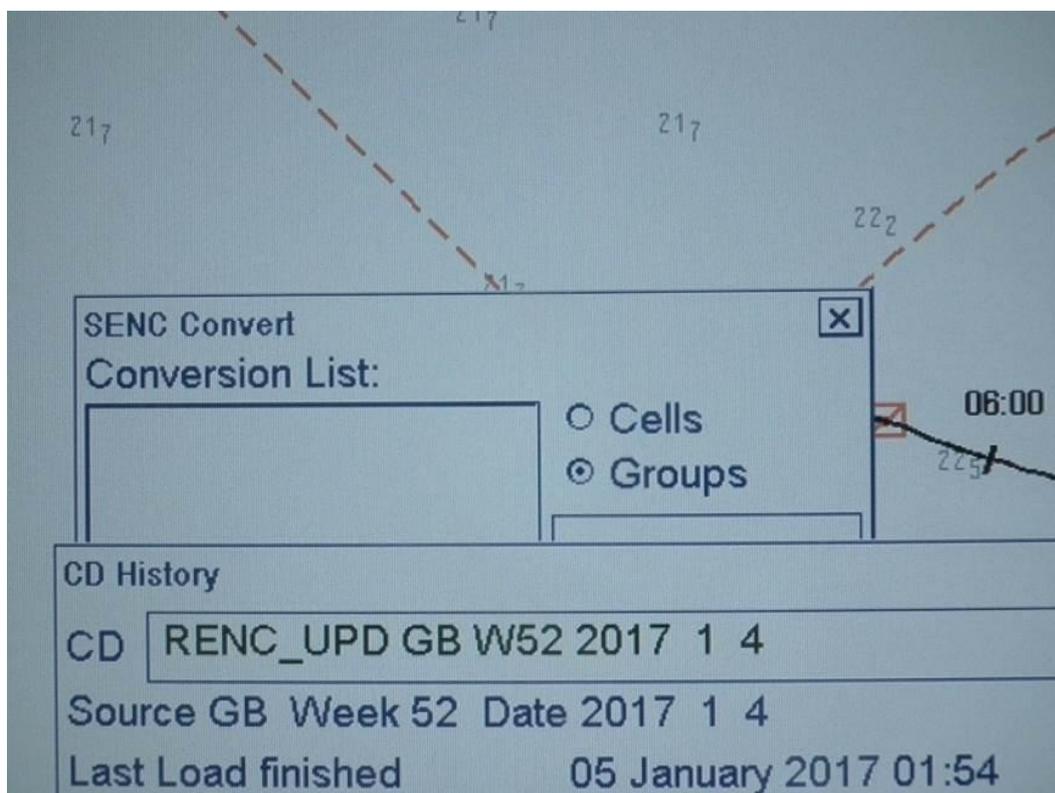
See below from ship following successful update.

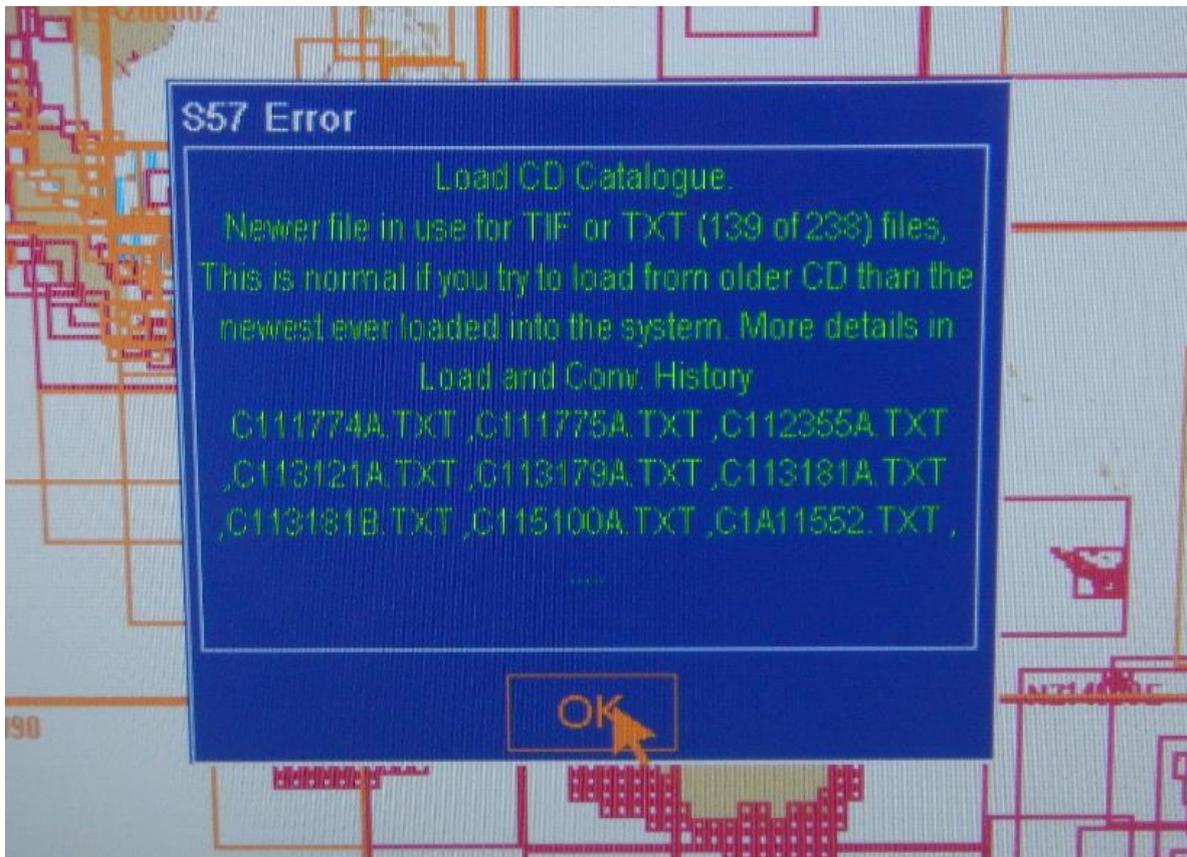
The photo below is from the previous case as described in the attached email. The error message is pretty self explanatory, however the officers did not understand what it meant.

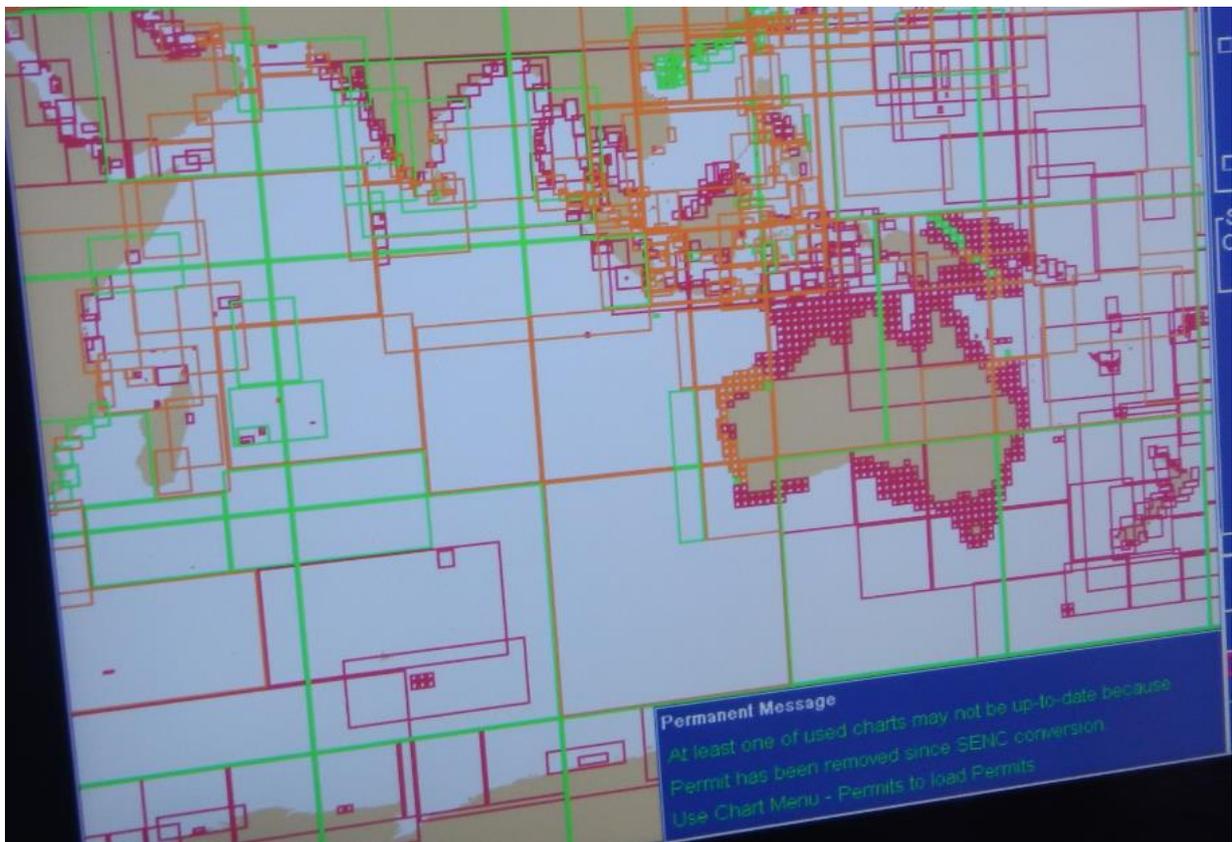
The master and superintendent told me that the ECDIS ENC licence permits from the company were loaded and the ENC were updated with latest available CD ROM just prior to me coming on board. When I inspected the ECDIS I requested to be shown the passage plan and ENC for the intended voyage as well as all the licensed ENC. The master and officers had difficulty in bringing up the diagrammatic screen showing all ENC available. After some confusion and delay the screen was found. The ENC for the intended voyage were outlined orange while other ENC were mostly outlined red and a few were green. There was also a permanent message that charts may not be up to date because the permit has been removed. See below.

I asked the master, officers and attending superintendent what the ENC colour codes represented; after initially telling me the ENC were up to date, they admitted the ENC were not up to date or cancelled after referring to the ECDIS operation manual. Red means no permit, green means has permit and is up to date. As per the operations manual orange means "the chart is available for use in SENC format but the chart is either not up to date or has been cancelled". I also asked them what the permanent message and other message meant and again they did not get the correct answers.

The superintendent contacted the company's ENC & tech support provider (Marine Press of Canada) by telephone and emailed a screen shot of the ECDIS as well. The tech support people diagnosed the problem that updating the ECDIS ENC with the new company licence did not allow updating of the ENC provided on the previous licence (not exactly as simple as that). I had come to that conclusion myself when I saw that the Port Hedland harbour ENC was green therefore updated. The master told me that they had obtained the permit for the Port Hedland harbour ENC from the new provider Marine Press of Canada. The other ENC that are green are those that have no updates (mostly ocean charts, China and Indian coastal).

Marine Press of Canada emailed the fix (new permit numbers I guess) to be loaded on to the ECDIS.

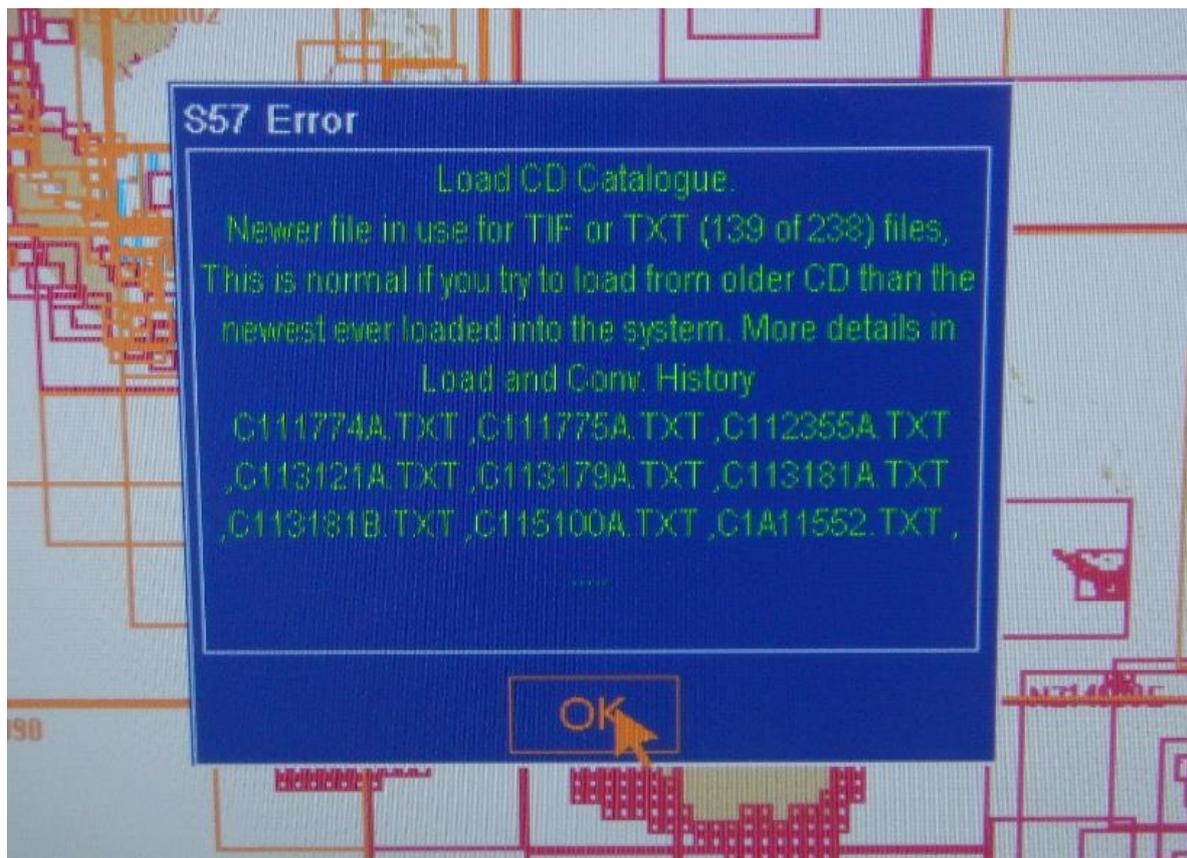
There was another message which the master and officers were unable to explain the meaning of (it was not necessarily a real error message) see below.

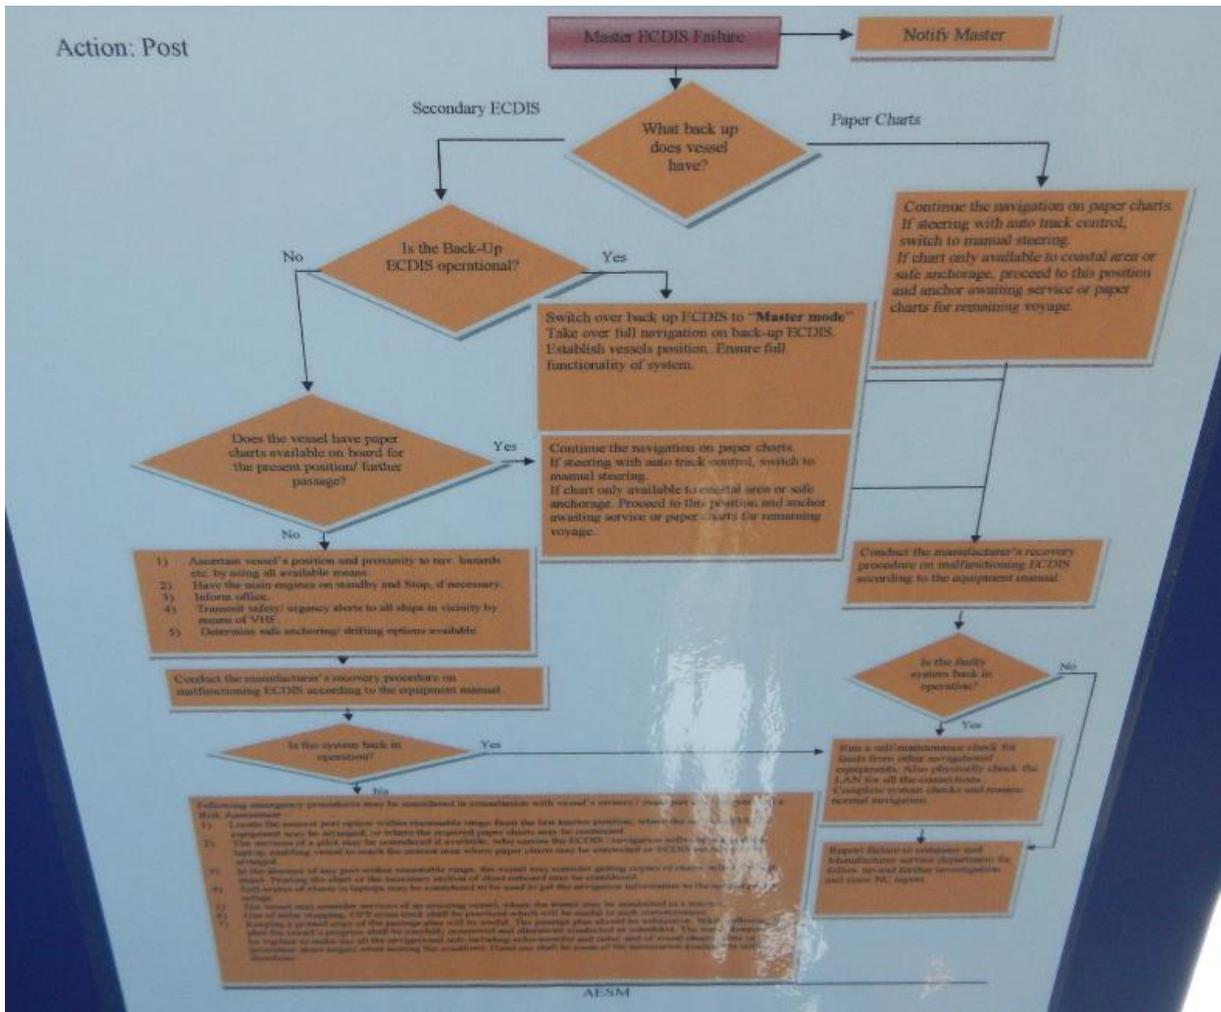
Less reassuring was the company contingency procedure for ECDIS failure, see below.

Added by AHS - The key points within the lowest action box from this image include:

Following emergency procedures may be considered in consultation with vessel's owners / managers ... a Risk Assessment	
1)	Locate the nearest port option within reasonable range from the last known position, where the service TEC?... equipment may be arranged, or where the required paper charts may be connected.
2)	The services of a pilot may be considered if available, who carries the ECDIS / navigation software ... laptop, enabling vessel to reach the nearest area where paper charts may be connected or ECDIS service may be arranged.
3)	In the absence of any port within reasonable range the vessel may consider getting copies of charts online? ... email. Printing the chart or the necessary section of chart onboard

<i>may be considered.</i>
4)	<i>Soft copies of charts in laptops may be considered to be used to get the navigation information to the nearest port or refuge.</i>
5)	<i>The vessel may consider services of an assisting vessel, where the transit may be conducted in a convoy.</i>
6)	<i>Use of radar mapping, GPS cross track shall be practiced which will be useful in such circumstances.</i>
7)	<i>Keeping a printed copy of the passage plan will be useful. The passage plan should be exhaustive. While following the plan the vessel's progress shall be carefully monitored and alterations conducted as scheduled. The watch keeper ... be vigilant to make all use all the navigational aids including echo-sounder and radar and of visual observations of prominent shore targets when nearing the coastlines. Good use shall be made of the information in sailing directions.</i>
