Paper for Consideration by ENCWG4

Dangers highlighted by Sector lights intersections

Submitted by:	Australia (AHO)
Executive Summary:	The grounding of the Dutch freighter 'Nova Cura' in 2016 highlighted the sub-standard depiction of a navigational danger in ECDIS when compared with its paper chart equivalent. The area to be avoided was marked by 2 intersecting light sectors. ENC encoding practices should be improved to provide ECDIS with data capable of activating its in-built safety functions.
Related Documents:	NCWG4-10.2A
Related Projects:	S-101PT

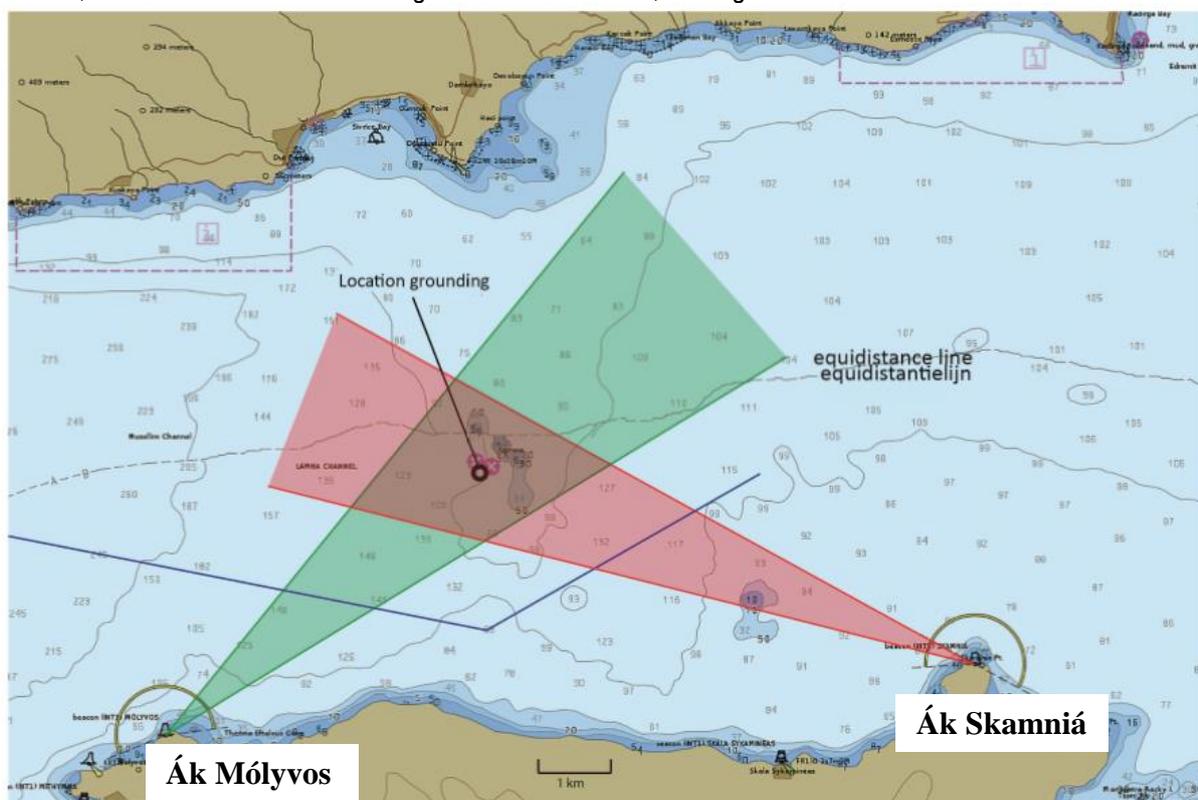
Figure 8: Sector lights in Mytilini Strait. Source: GR4APP01

The sector lights Ák Mólivos and Ák Skamniá are both intended to warn of the danger of Lamnas Reef. In this case, the danger is located in the area illuminated simultaneously by both the green and the red sector lights. For the passage south of Lamnas Reef, coming from the west as the Nova Cura had intended (on the left of Figure 8), the vessel should approach in the left white sector of Ák Skamniá (see blue line in Figure 8). Only when the vessel has passed the green sector of Ak Mólivos, can it go to the port side; in this case, both sector lights are white. After that, the vessel passes the red sector of Ak Skamniá and has passed Lamnas Reef. The coordinates of the area covered by the sector lights were also stated in the Pilots for the area (NP48). It is not forbidden to sail in the green or red sector of sector lights.

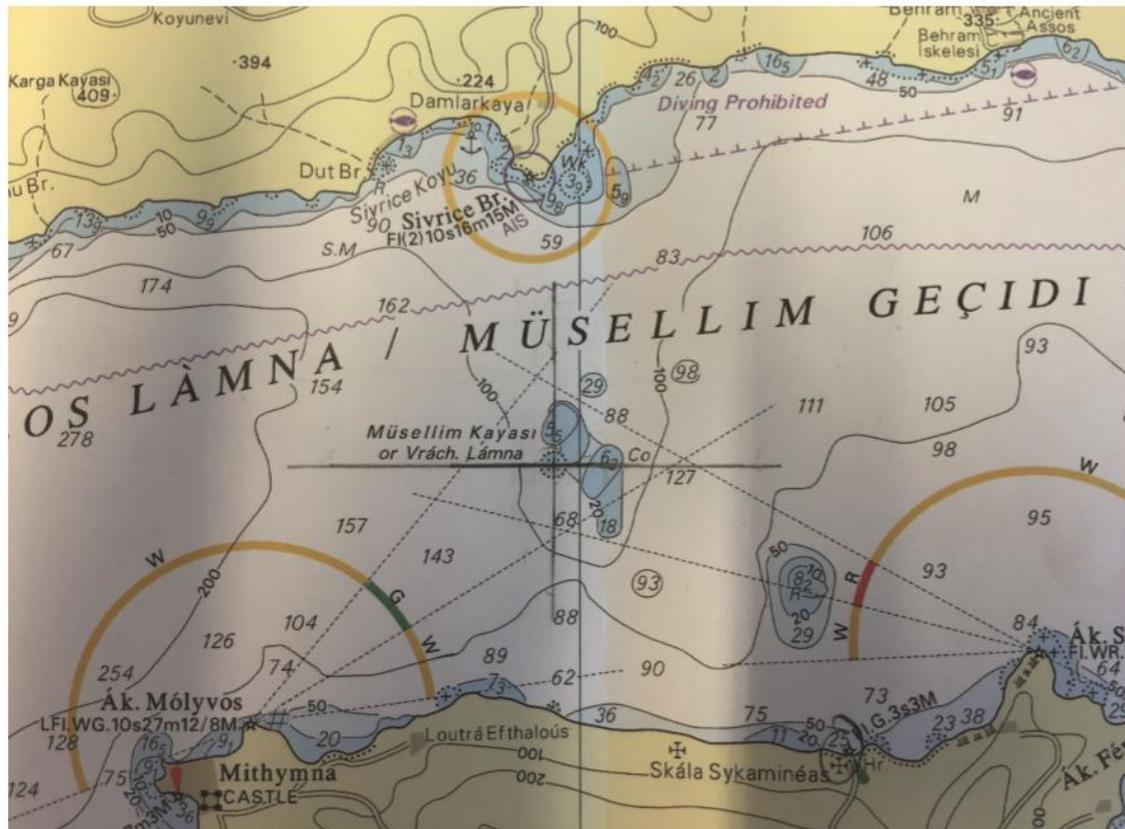
Figure 9: Lamnas Reef in BA1061.

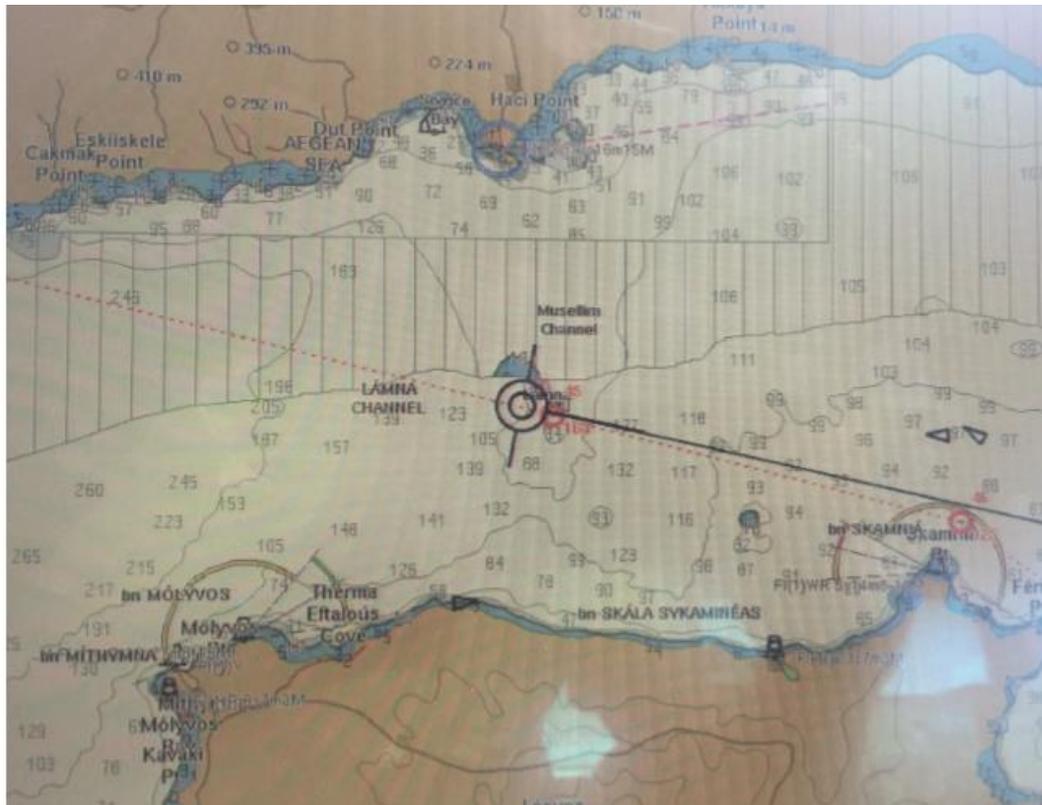
Where 'full length light sector lines' option is turned Off (see image above- 25mm length) or is On but the optional function to display light sectors even when their light structures are not in the display window is Off (or not available), the use of a CTNARE or RESARE object would certainly provide an additional safety net to mariners.

The existence of the 'No-go' area would be detected and indicated to the mariner at both the route planning and route monitoring stages.

The AHO considers that there should be a way of highlighting areas where sector lights intersect for a specific purpose. In this case to mark a 'No GO' area.

In the short term, this could be managed by 'double encoding' the 'NO-GO' area as an 'independent' CTNARE or RESARE object. This feature and the corresponding sector LIGHTS should be linked using an M_ASSO Meta object.
