ECDIS Display and Alarm Issues

Captain Vaughan Nail RN
12th NOIHC Colombo 20-23 March 2012

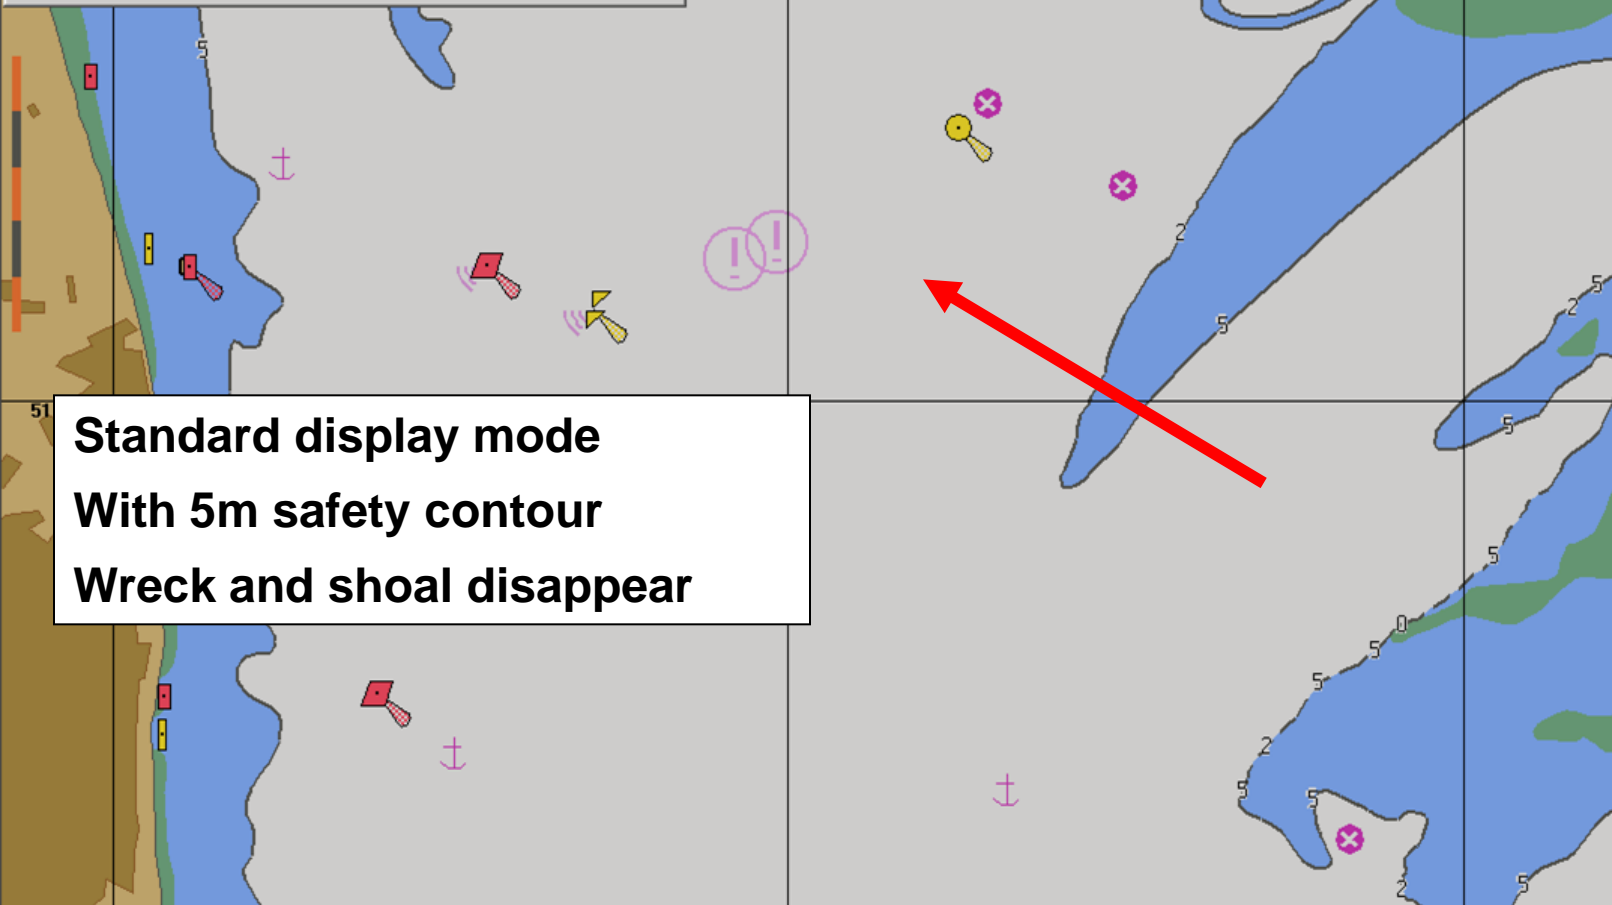
Standard display mode
With 5m safety contour
Wreck and shoal disappear

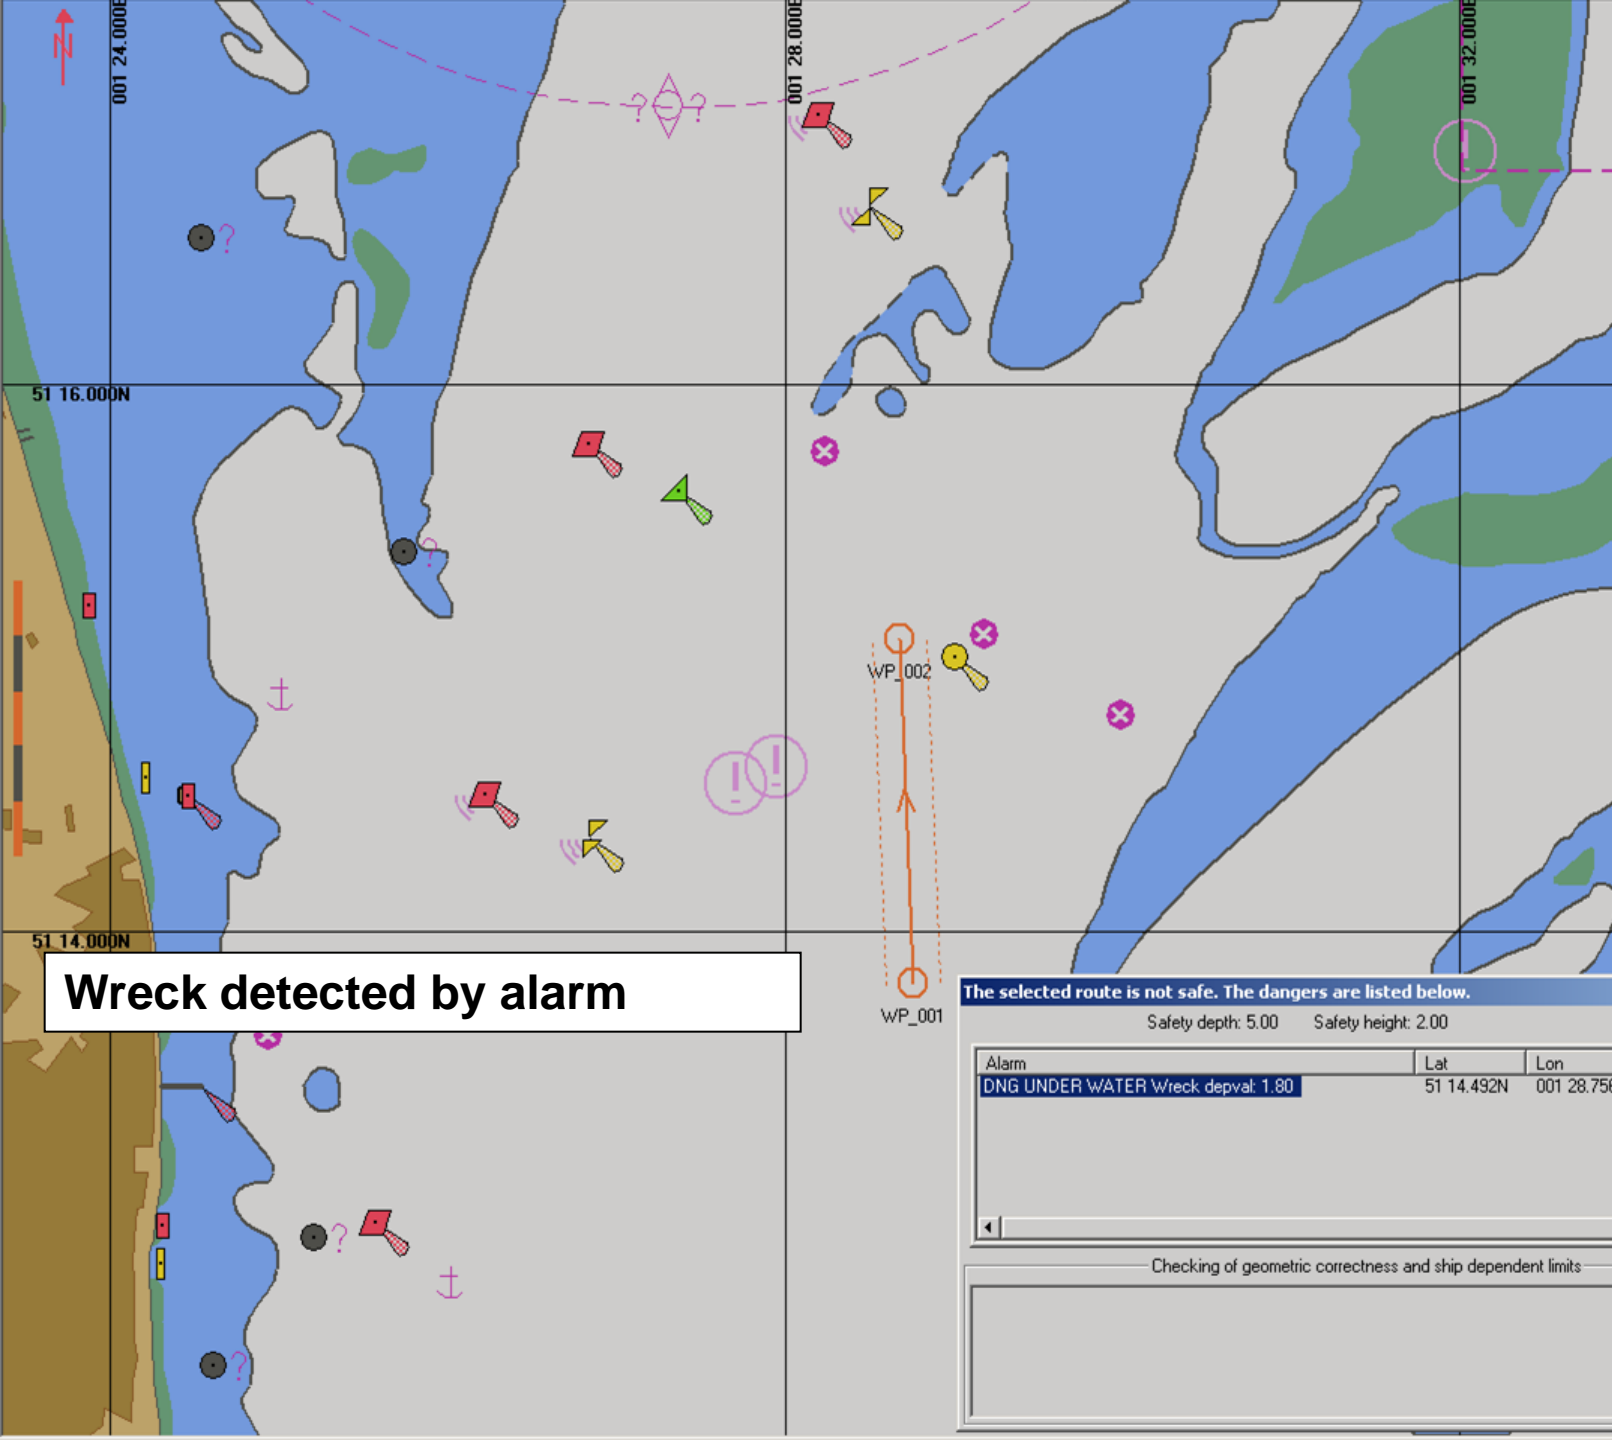
Wreck detected by alarm

Alarm	Lat	Lon	Leg
DNG UNDER WATER Wreck depval: 1.80	51 14.492N	001 28.756E	WP_001...WP_

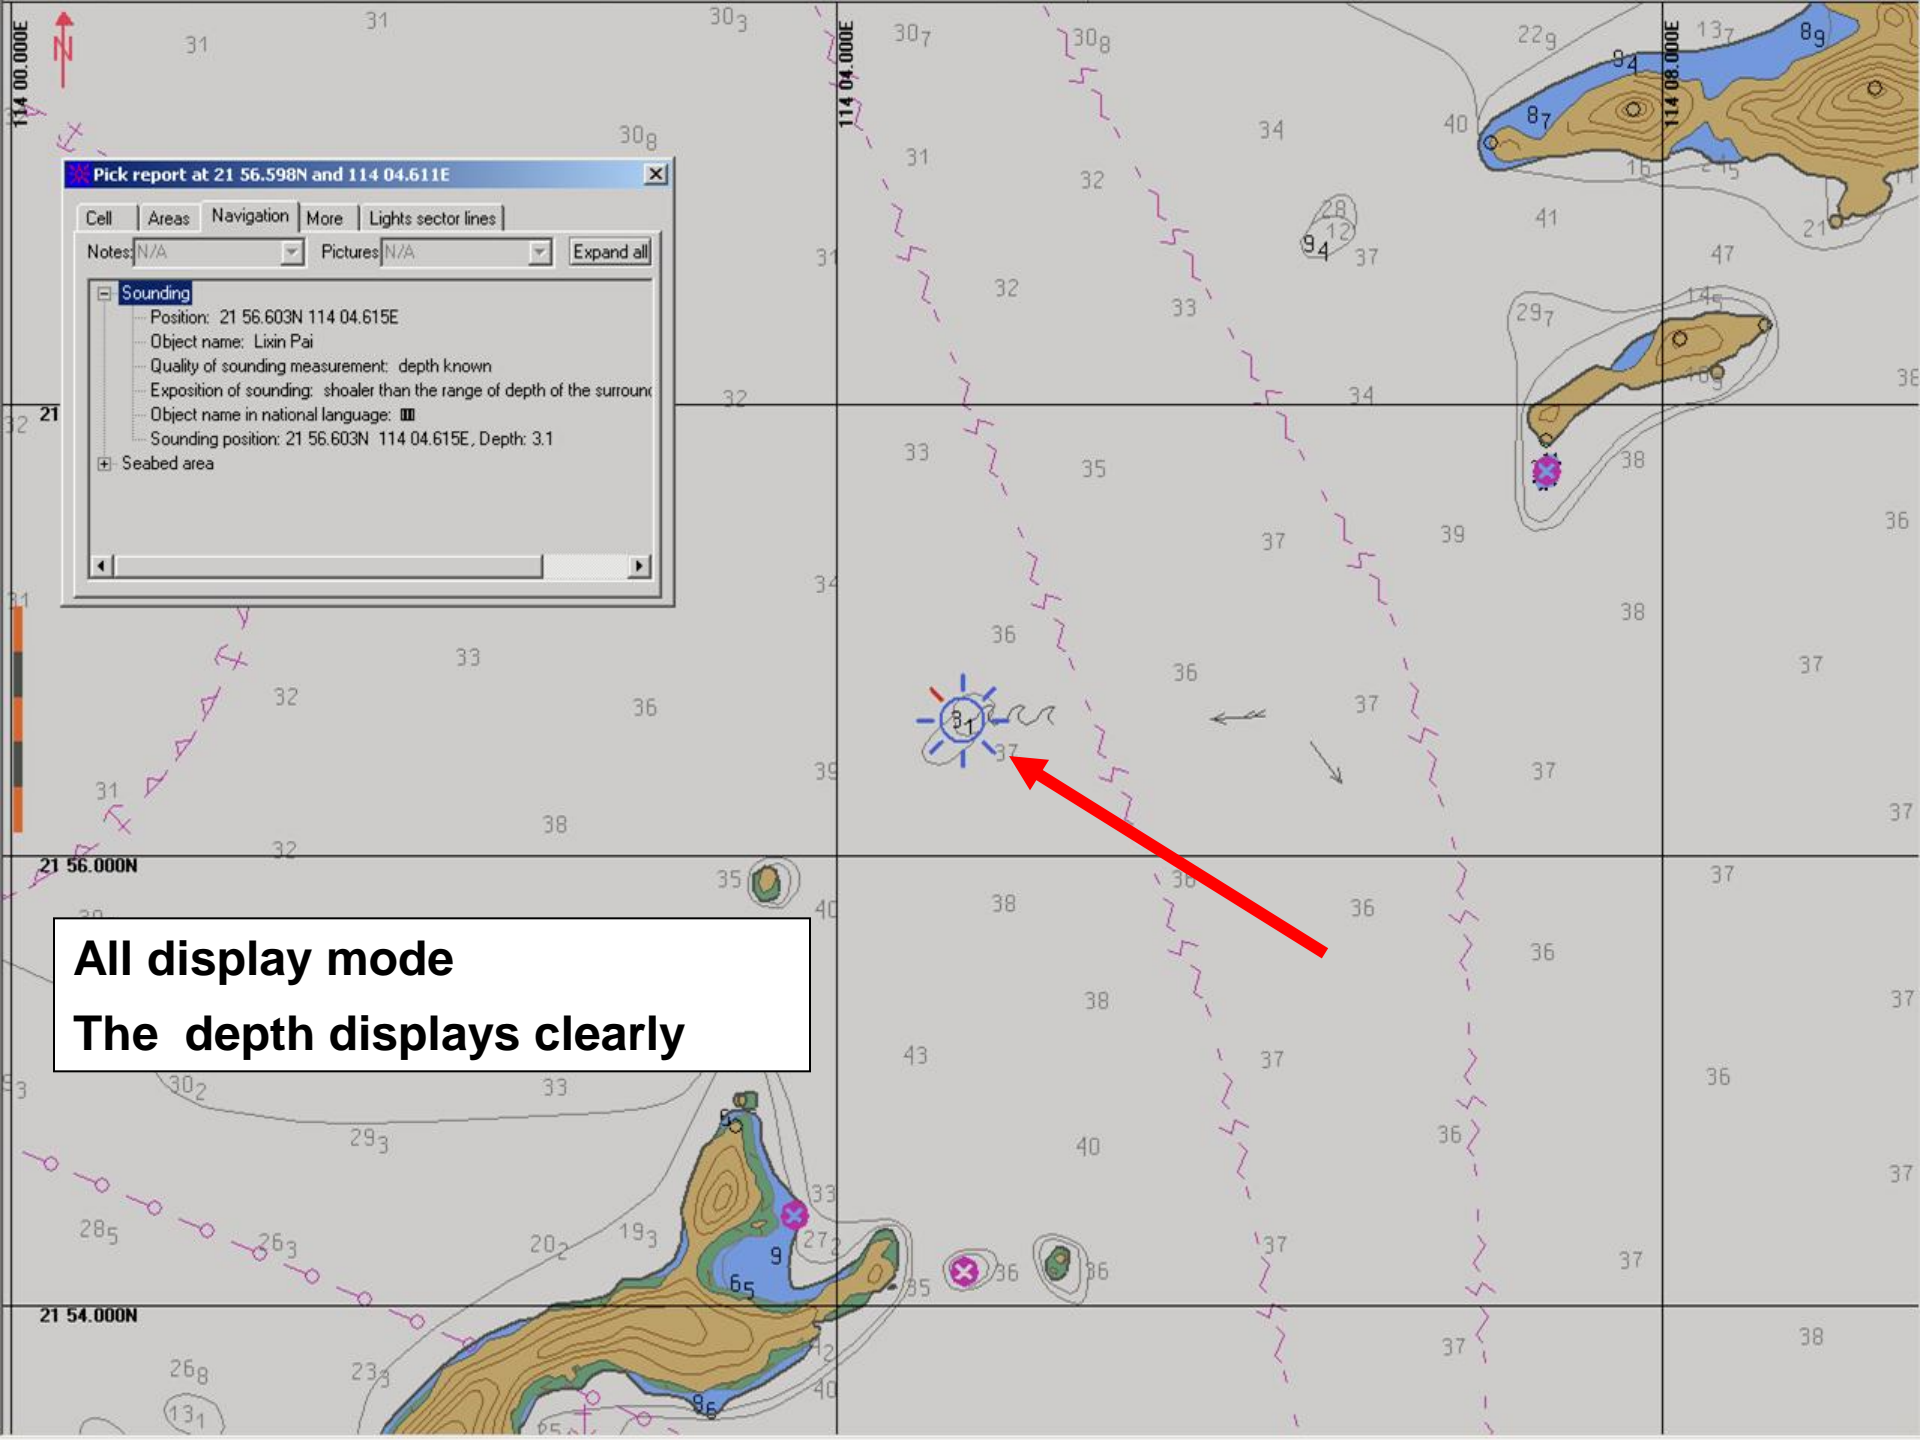
All display mode

The depth displays clearly

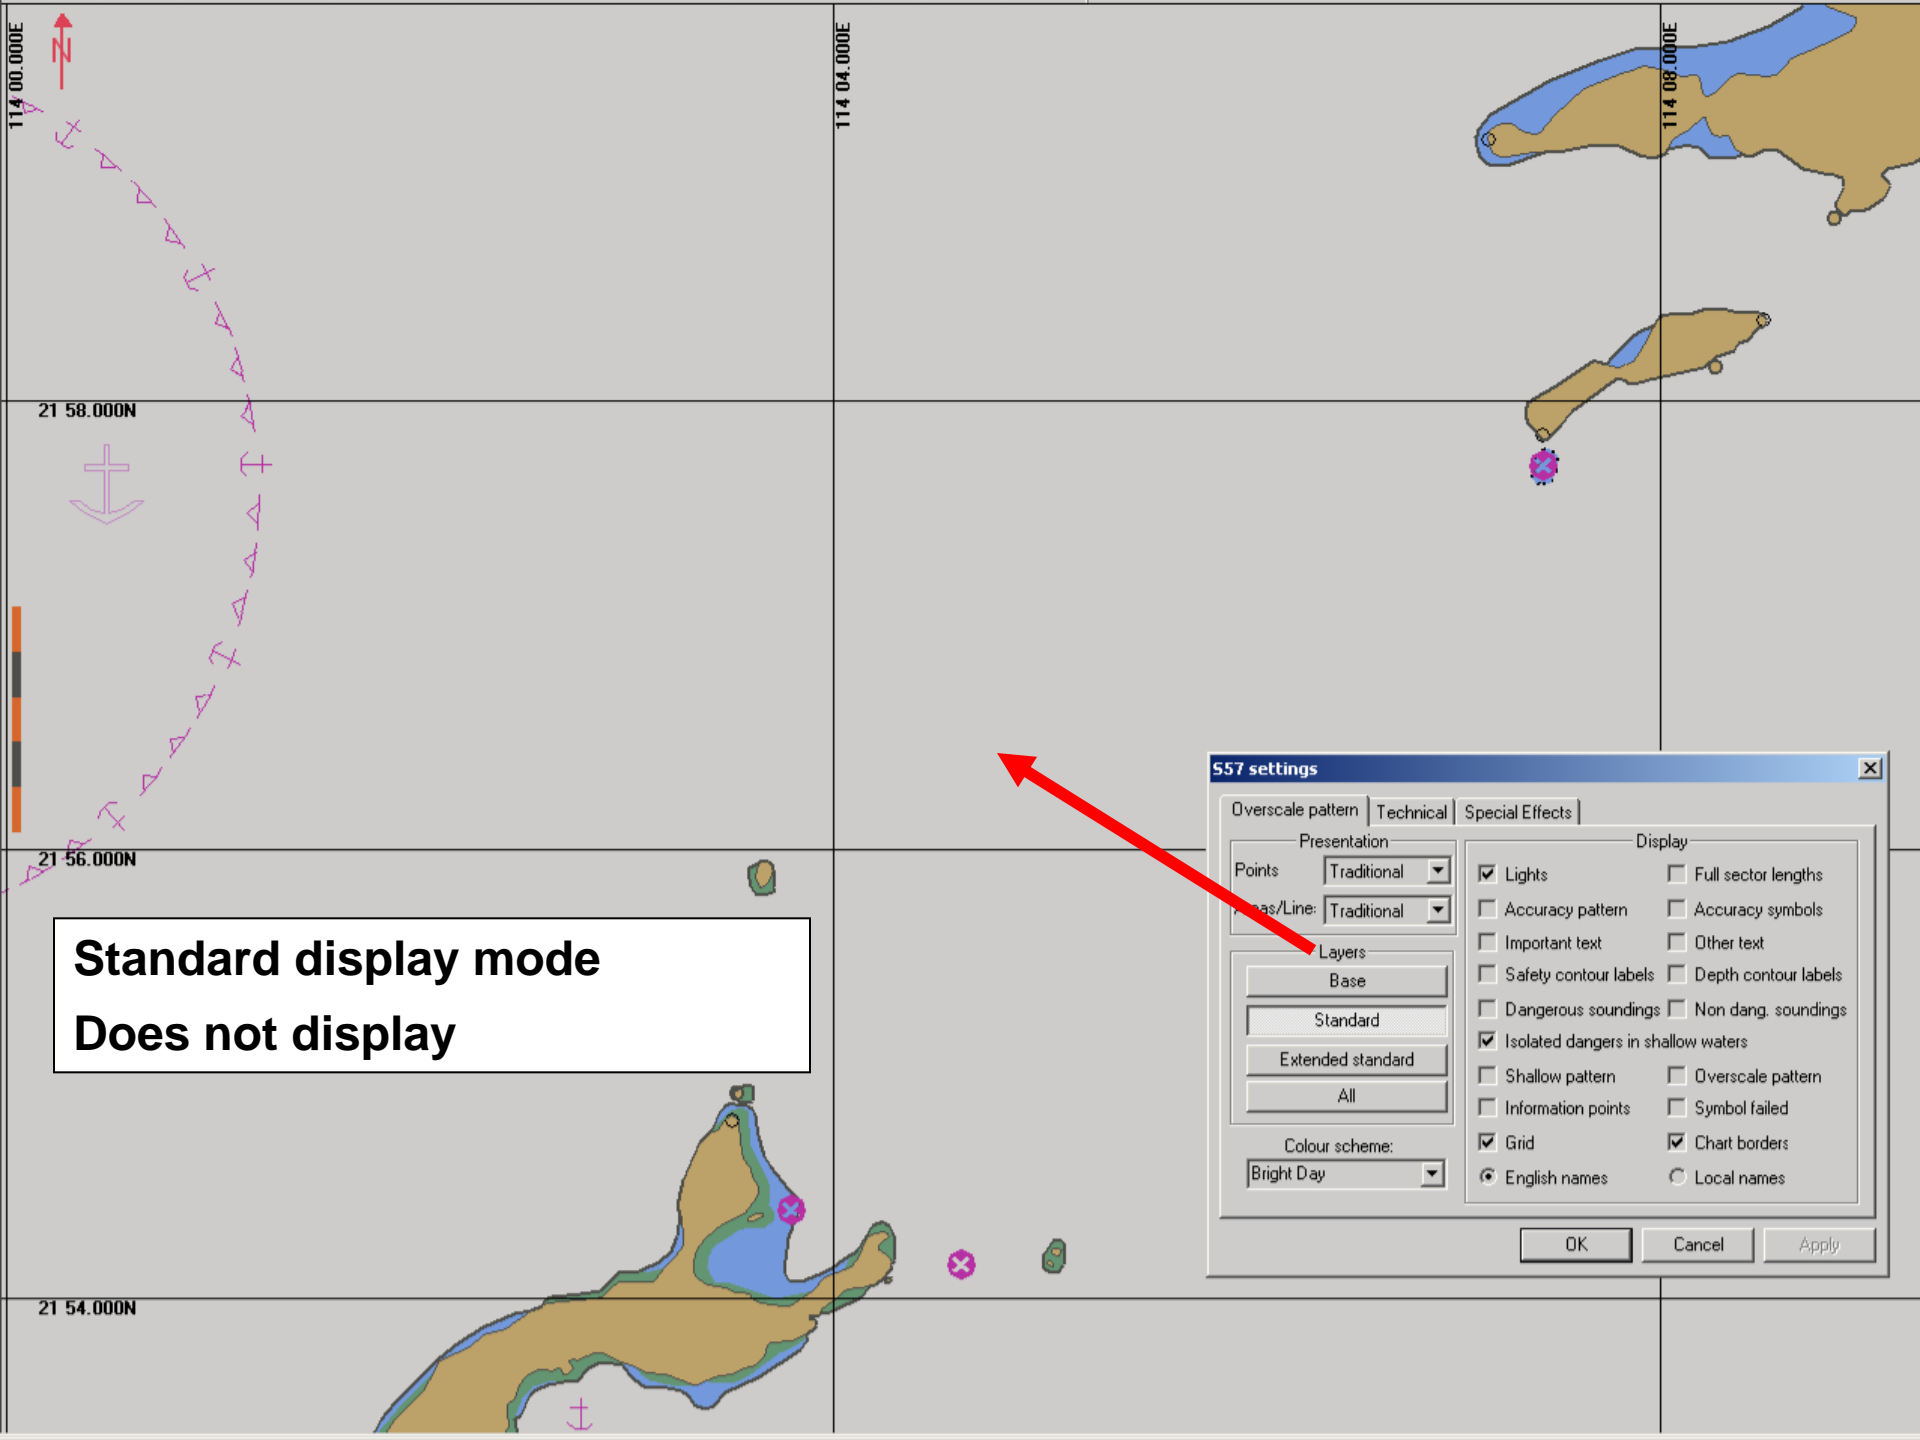
**Standard display mode
Does not display**

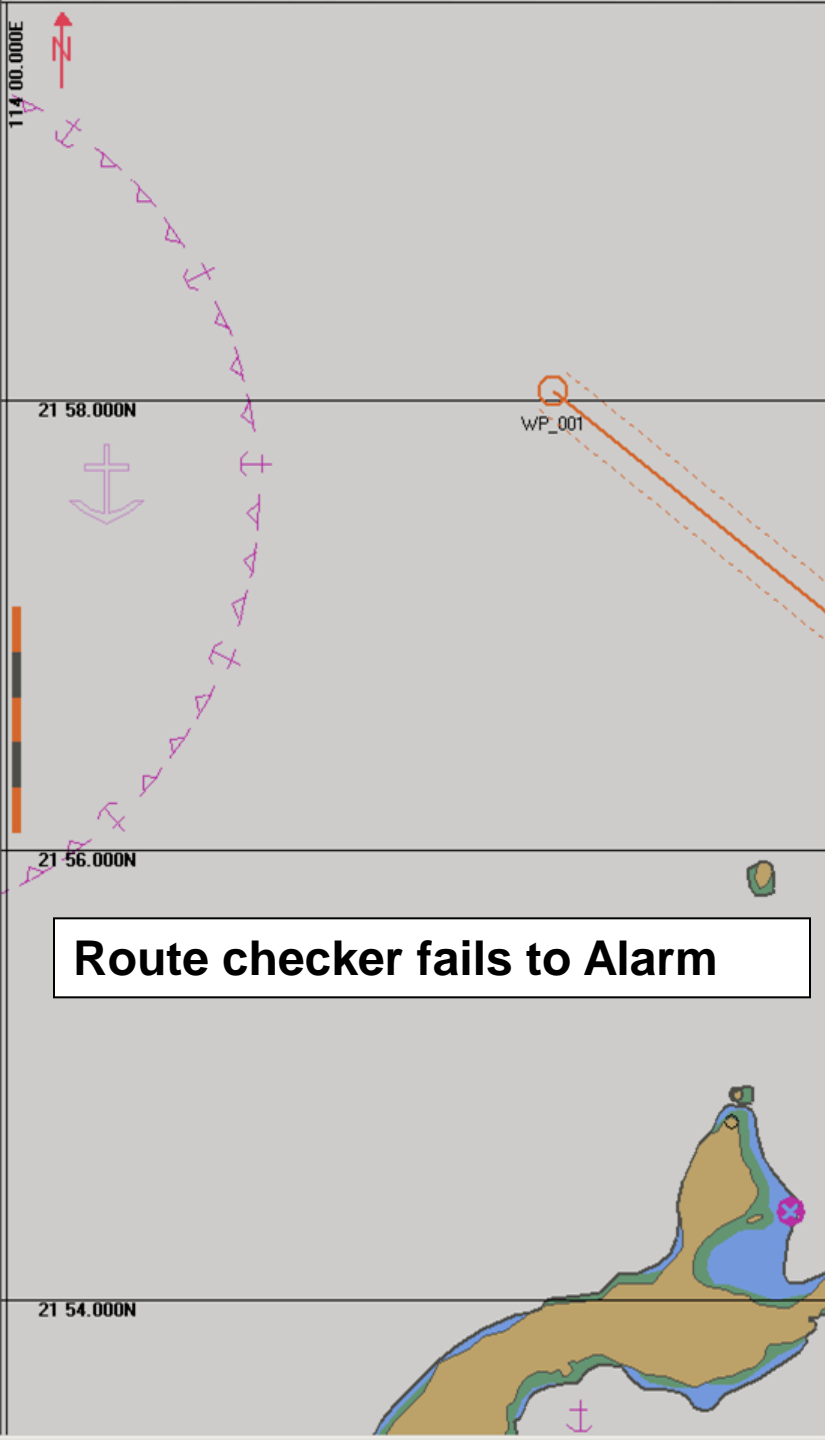
Route is safe [X]

Alarm	Lat	Lon	Leg
No alarms	N/A	N/A	N/A

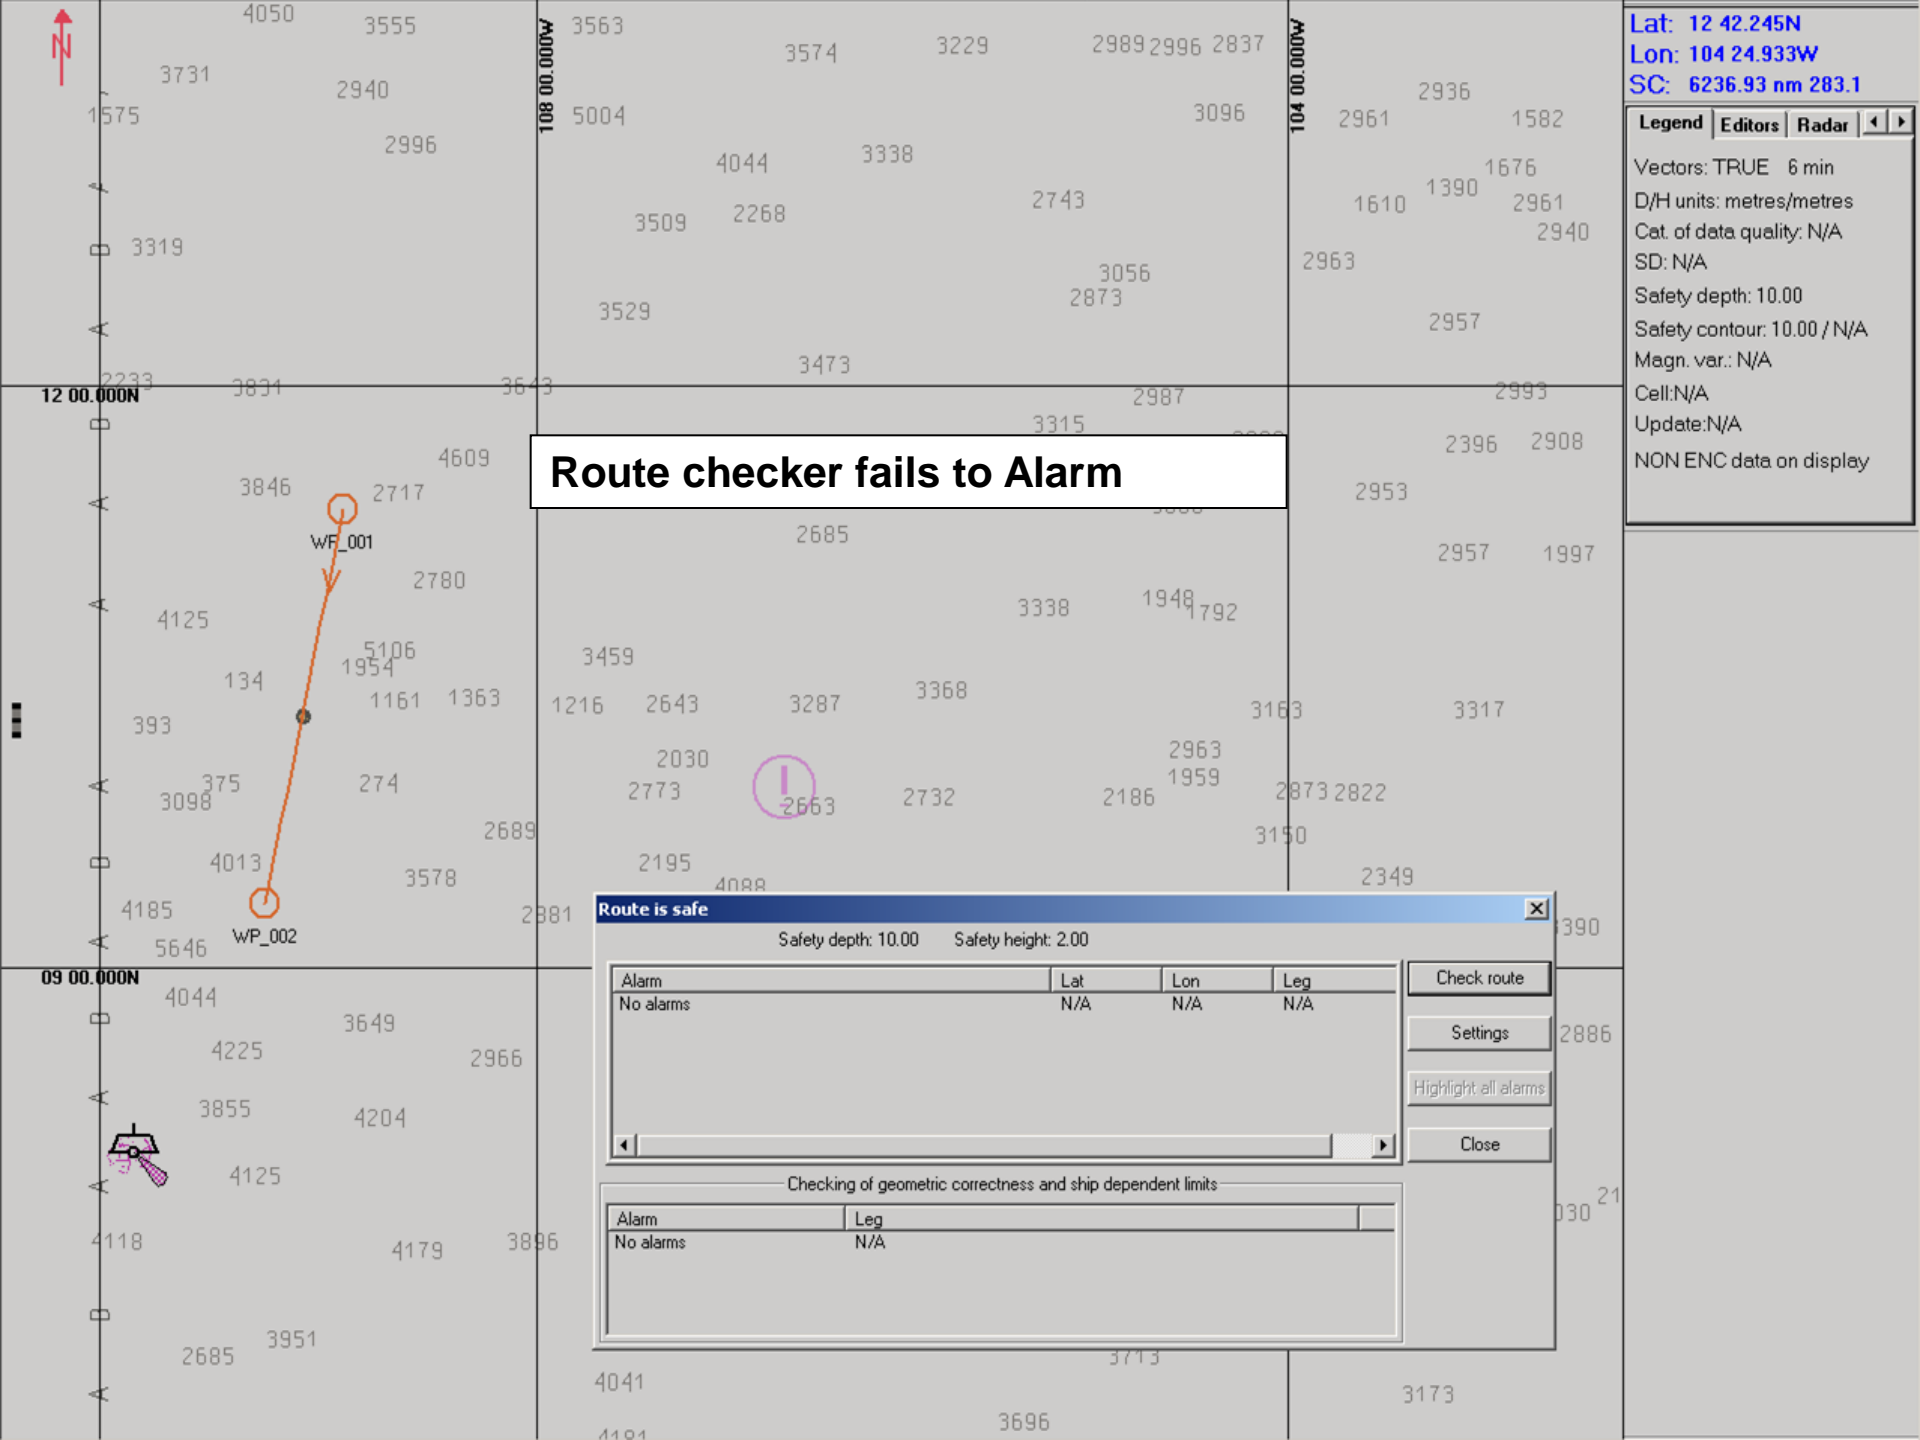
Route checker fails to Alarm

Route is safe

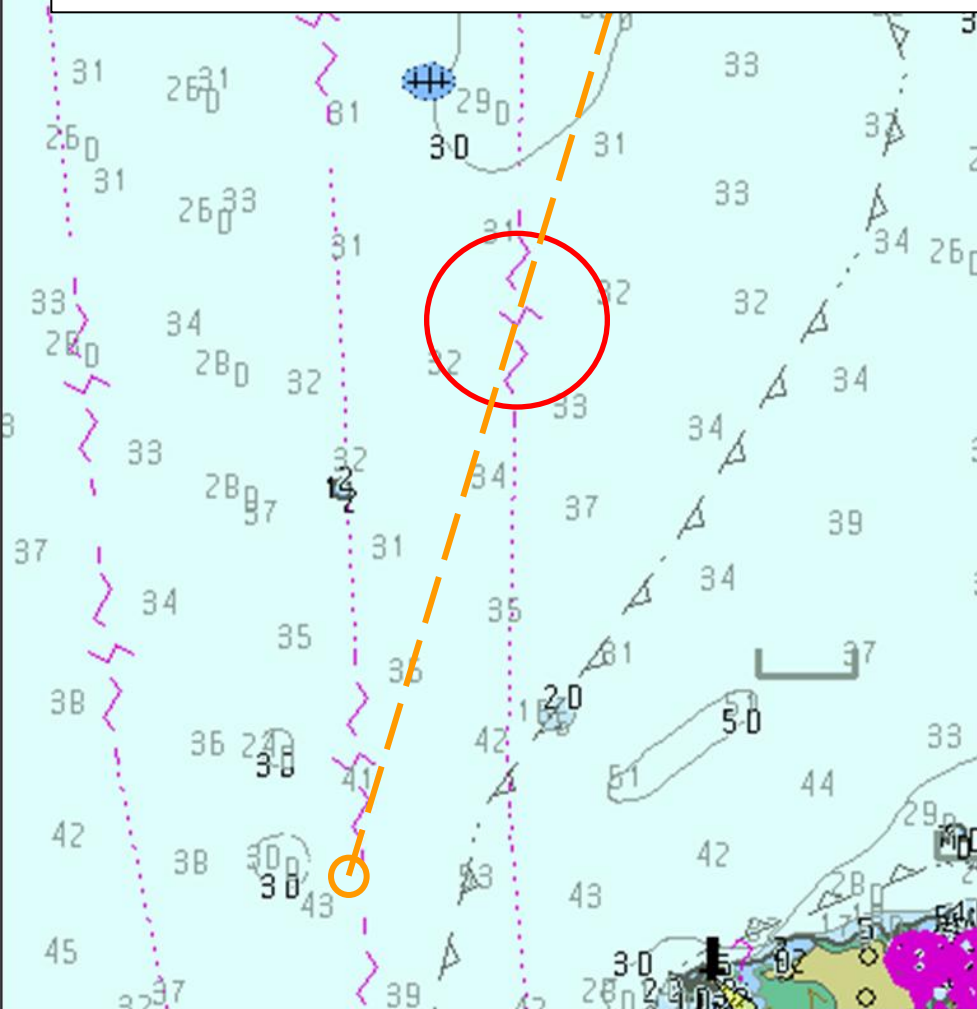
Issue: Doesn't display but does alarm

Stranded Wreck
