ECDIS Display and Alarm Issues

Captain Vaughan Nail RN
12th NOIHC Colombo 20-23 March 2012

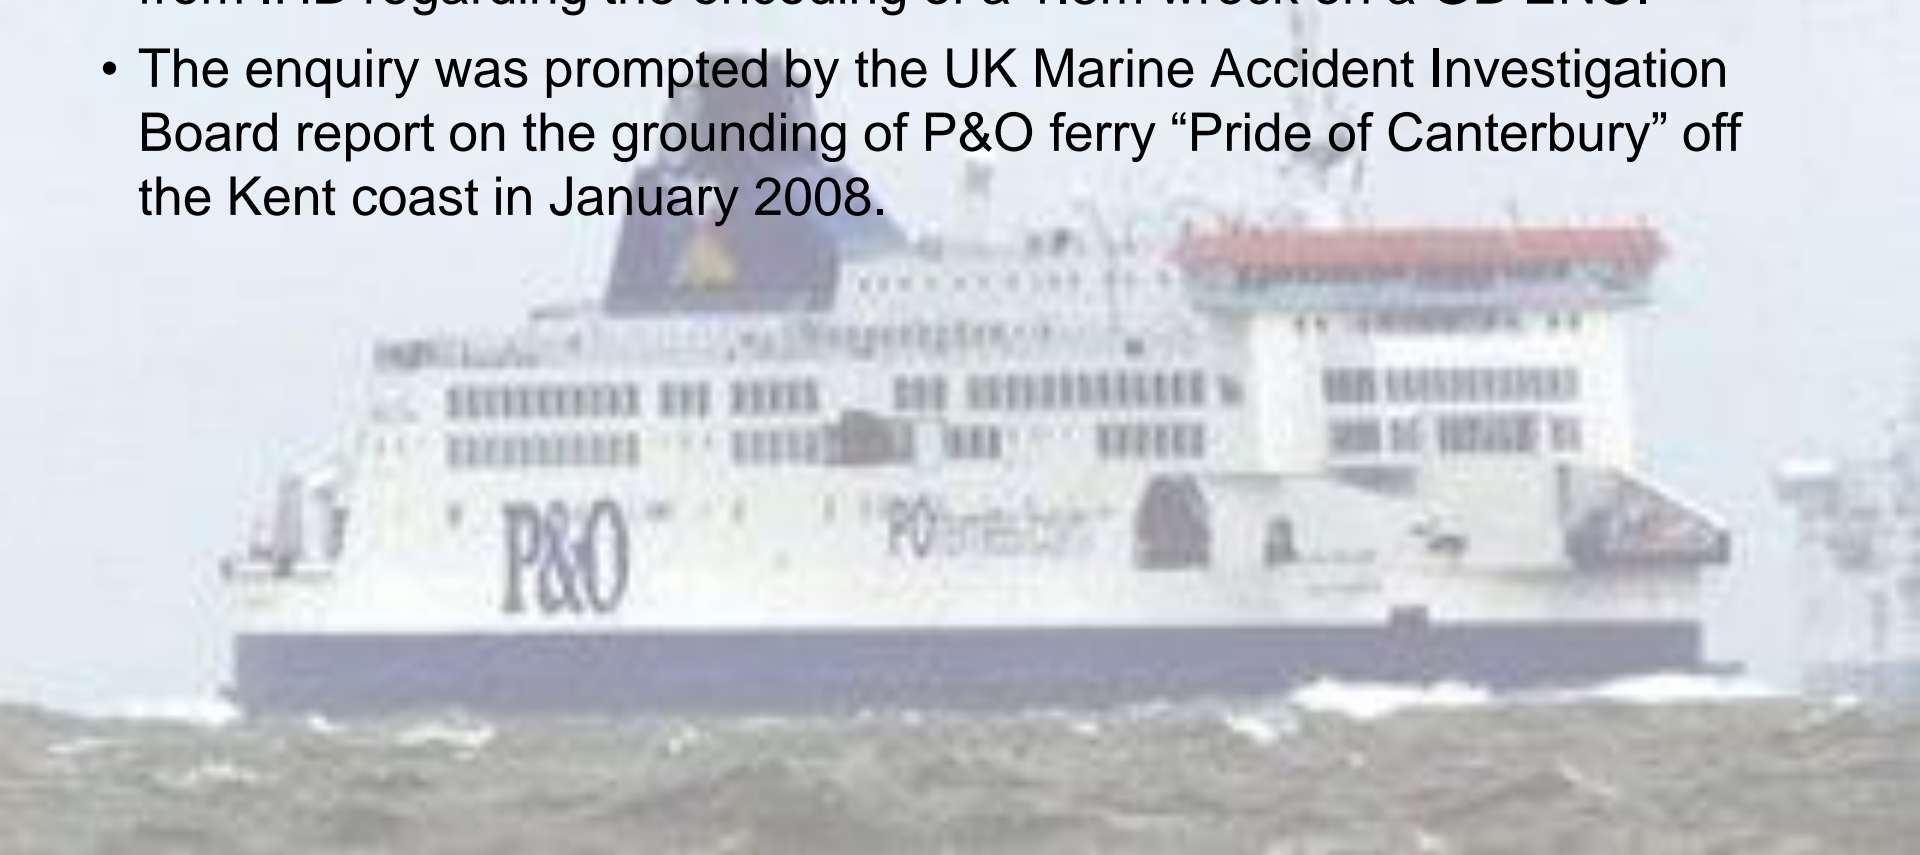
CASE 1 –DOES NOT DISPLAY BUT DOES ALARM

Wreck coincident with a depth contour

- This example came to light in January 2009 as a result of an enquiry from IHB regarding the encoding of a 1.8m wreck on a GB ENC.
- The enquiry was prompted by the UK Marine Accident Investigation Board report on the grounding of P&O ferry “Pride of Canterbury” off the Kent coast in January 2008.

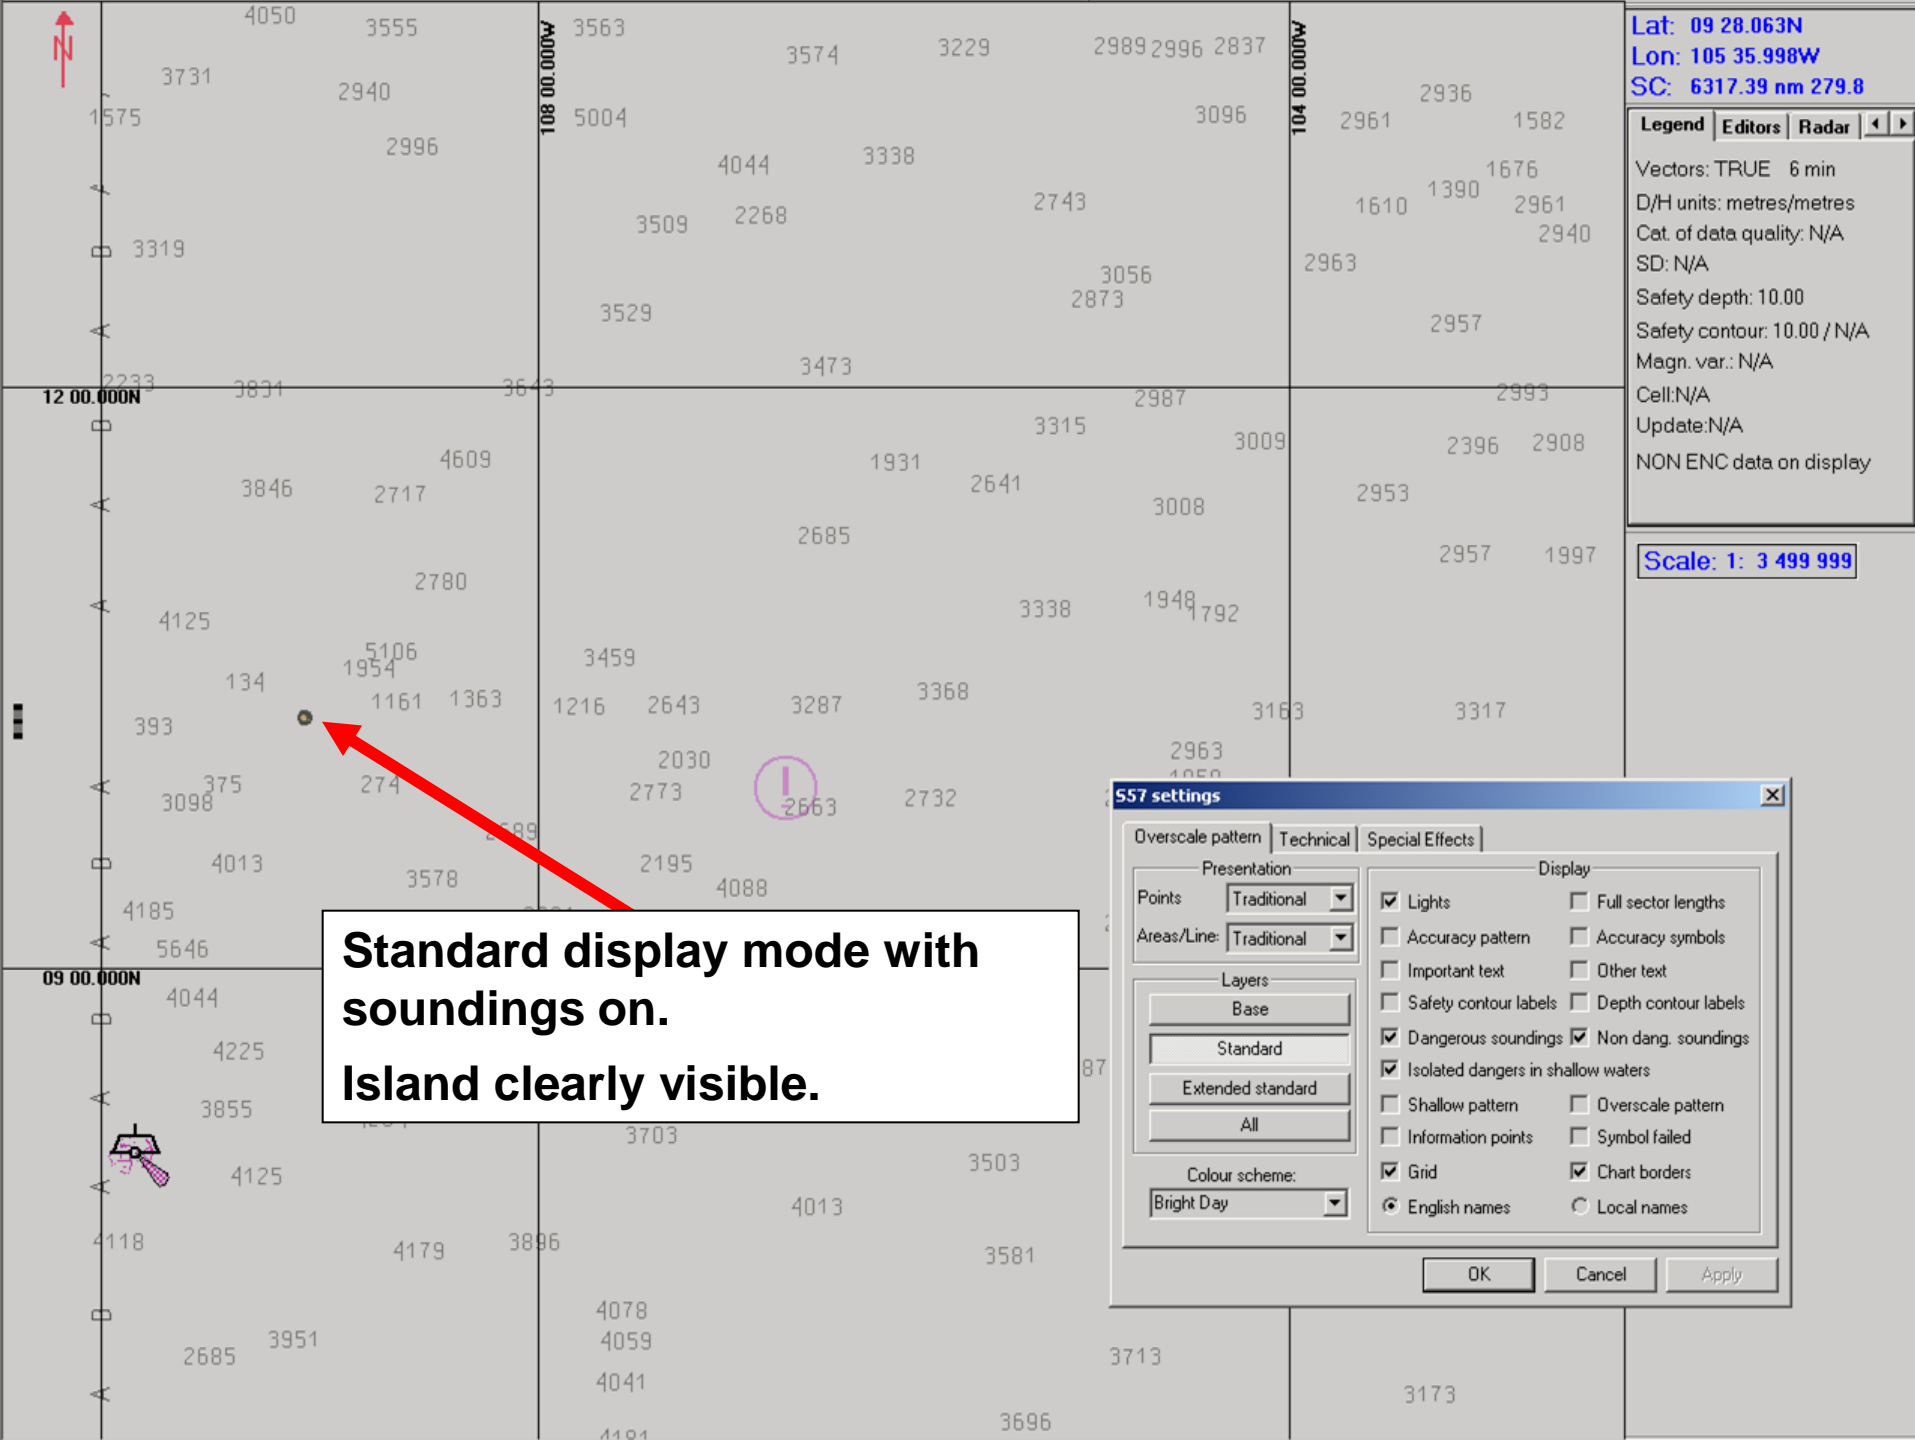
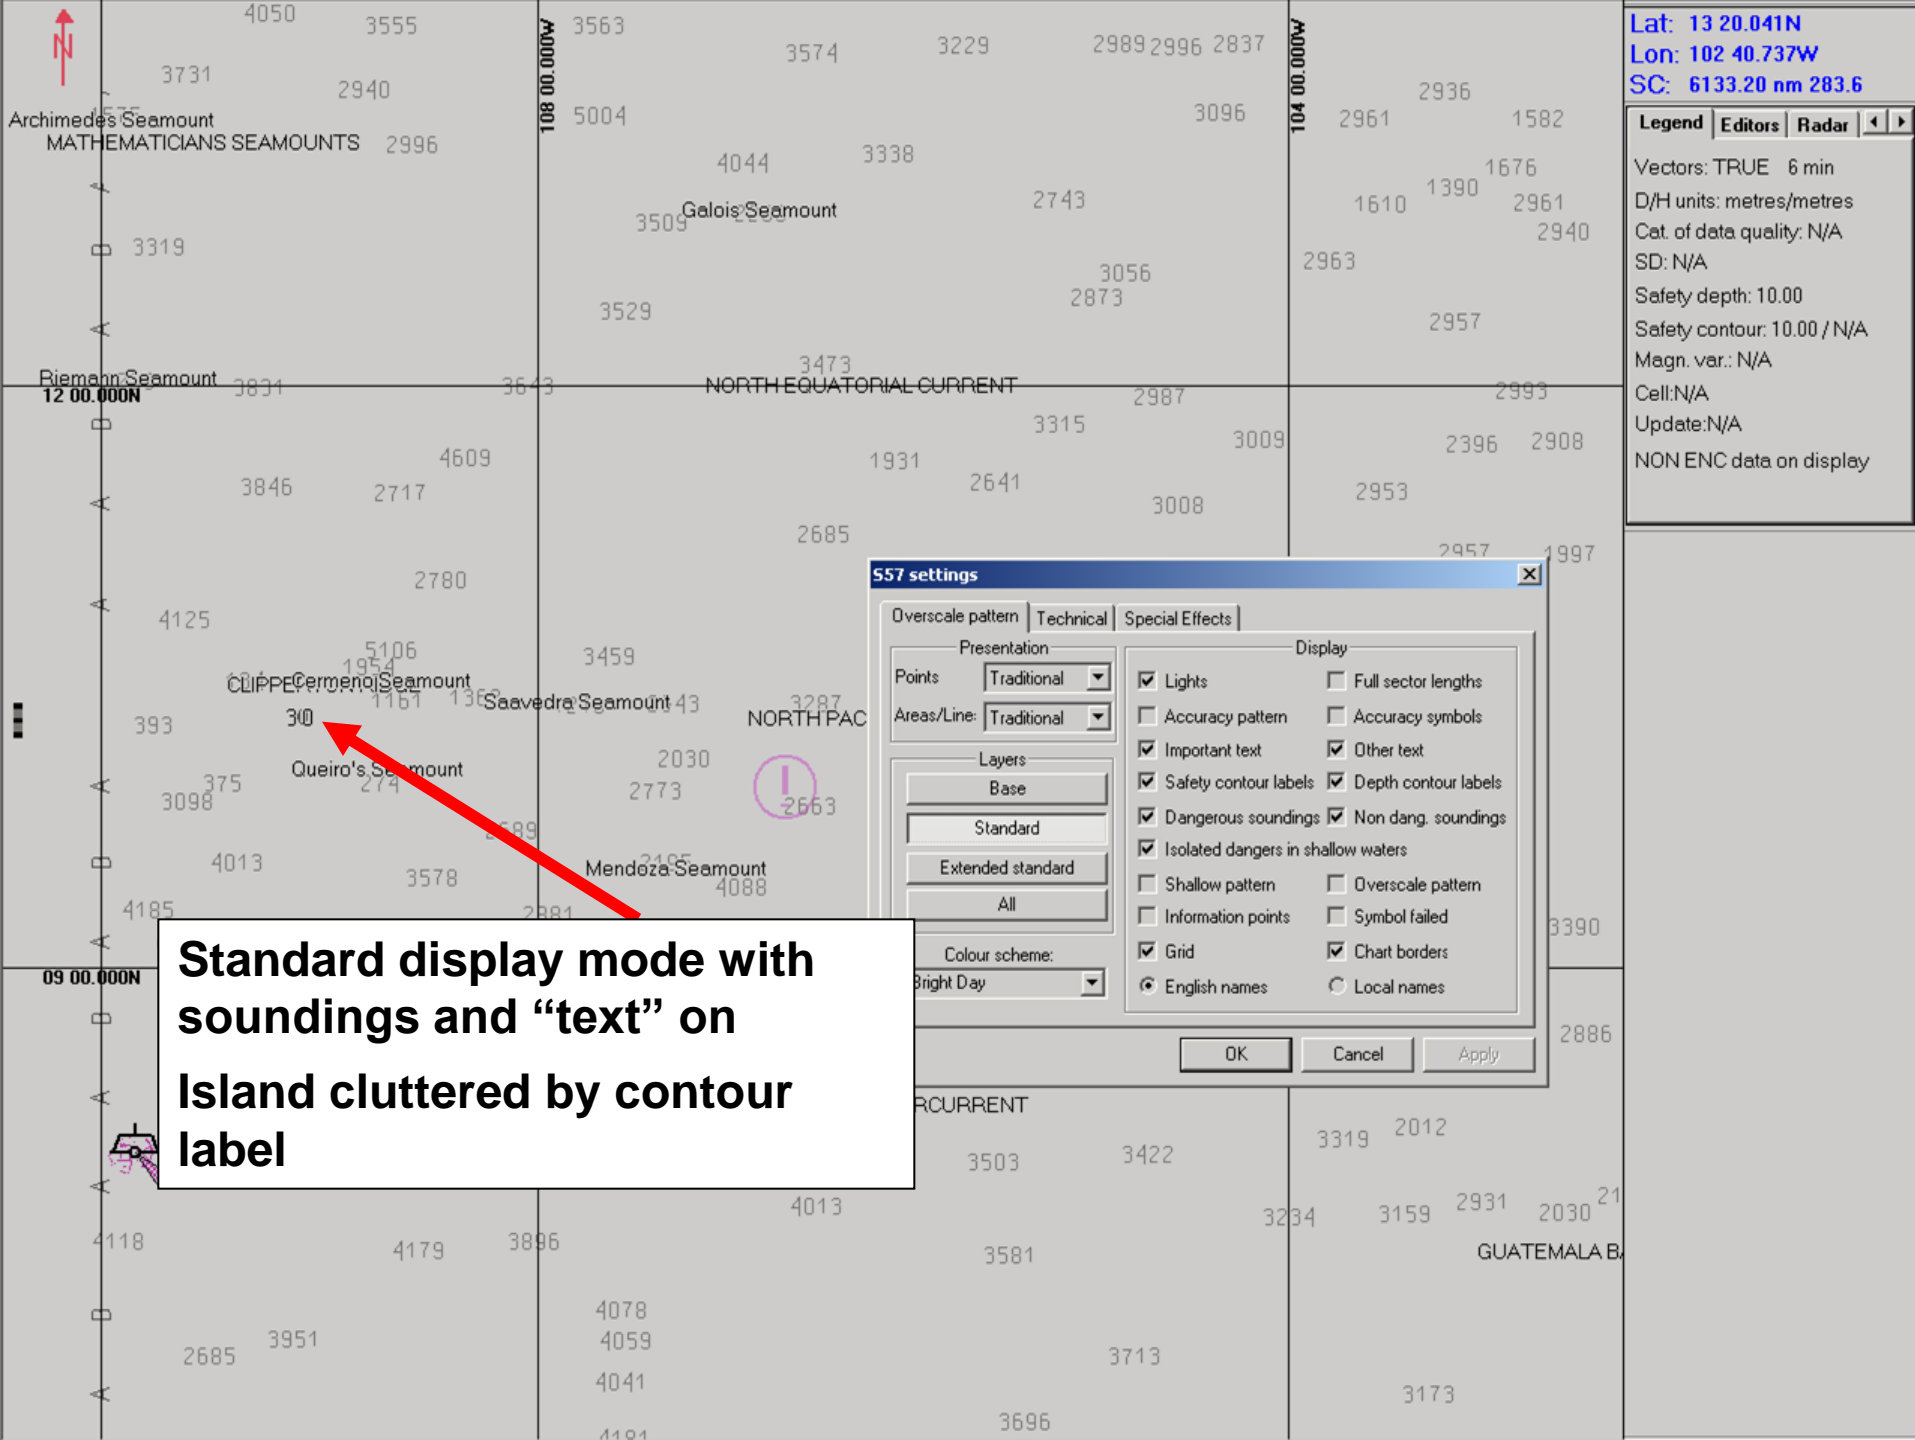
Sicheen Osprey aground on the reef at Clipperton Island near Clipperton Rock

Route checker fails to Alarm

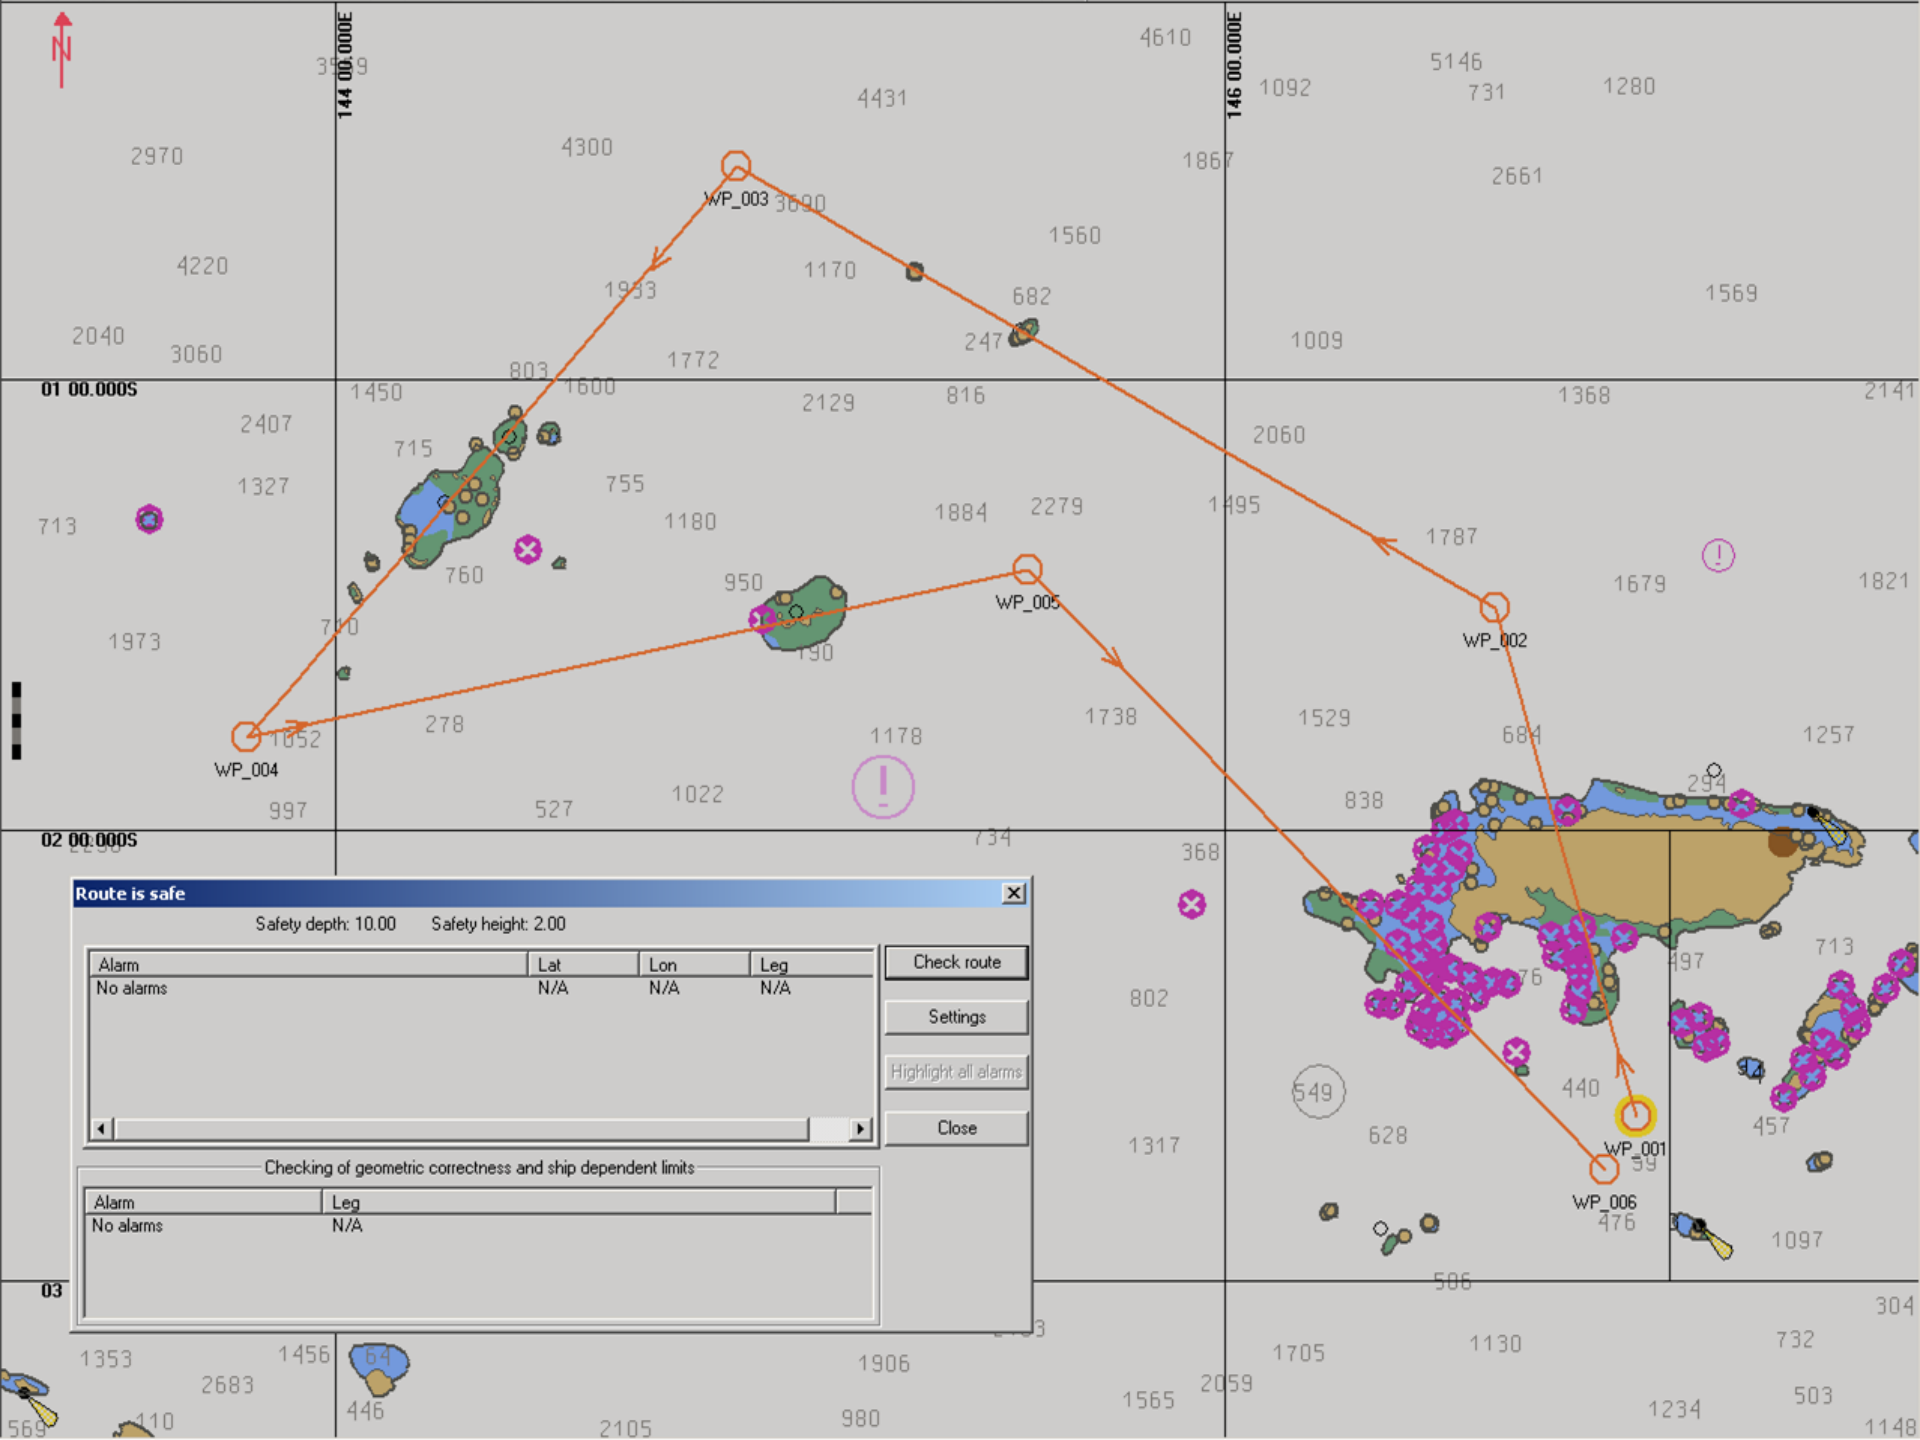
Route checking on small scale ENC's

- On further investigation, we found that some Original Equipment Manufacturers (OEMs) have implemented route checking with a scale limit.
- These scale limits have been implemented in different ways by different OEMs, perhaps assuming usage bands 1 or 2 will not be used for coastal navigation.
- IEC 61174 states: “The largest scale data available...shall always be used by the ECDIS for all alarms...”
- In many areas, small scale ENC's in usage band 1 or 2 represent the largest scale chart data available.

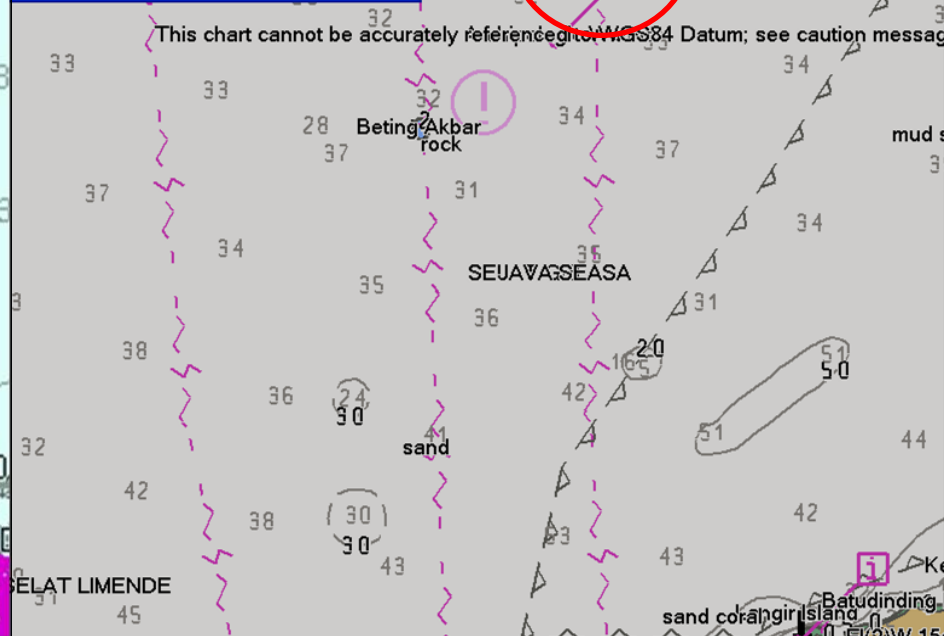
Issue: Doesn't display but does alarm

Stranded Wreck
